GOVERNMENT OF NEWFOUNDLAND AND LABRADOR Department of Transportation and Infrastructure	BRIDGE INSPECTION REPORT B01162023-6	
Date: 3/16/2022	Inspected By: Jeff Ward	Category: Eng. - Engineering	
BRIDGE INFORMATION			
Site:	1-064 - VICTORIA RIVER BRIDGE		
Route:		Overall Length:	26 m
Year Built:	1971	Est: No	Overall Width: 11.6 m
Year Last Rehab.:		Est: No	Roadway Width: 8 m
Region:	AVALON PENINSULA	Sidewalk Width:	1.1 m
Jurisdiction:	Provincial	Clearance to R.D. or N.W.L.:	1.5 m
Type of Structure:	01 - AASH to Girder	Max Depth of N.W.L.:	0.4 m
Purpose of Structure:	04 - Over Non-Navigable Waters		
Type of Handrail:	02 - Concrete Rail	Spans:	
Roadway Surface:	02 - Asphalt	Span No.:	Length
Alignment Vertical:	01 - Good	Span No.:	Length
Alignment Horizontal:	02 - Adequate	Span No.:	Length
Restrictions:	No	Span No.:	Length
		1	17.8
		2	0
		3	0
		4	0
		5	0
		6	0
BRIDGE PHOTOS

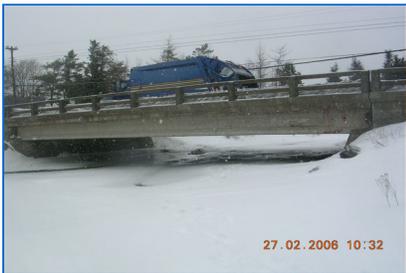
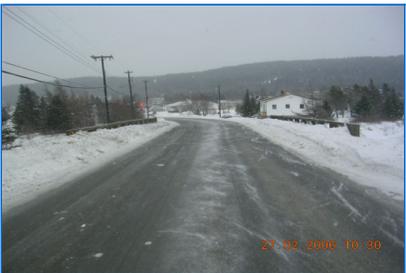
Bearing Seat:	F2 - Fair
Comments:	Medium erosion to north footing. (assumed condition of south footing, buried). Hairline to narrow vertical cracks in abutment faces primarily between girder bearings as well as in faces of wingwalls.		
SUPERSTRUCTURE			
Condition:	F2 - Fair	Expansion Joints:	F1 - Fair
Comments:	Hairline to narrow horizontal cracking over bearing seats @ girders typical. North outlet girder has vertical cracking and light efflor. Honeycombing @ underside of deck. East fascia has light to medium efflor. Moderate honeycombing in ballast walls typical.		
DECK

Condition:	F2 - Fair	Curbs:	F1 - Fair
Hand Rail:	G - Good	Roadway Condition:	F2 - Fair
Approach Rail:	F2 - Fair		
Comments:	East and West curb and fascia shows medium longitudinal cracking with efflor. Minor damage to north west and southwest guardrails at buried ends. West soffit shows signs of minor cracking and spalling. Expansion joint damns visible with moderate wear. Asphalt cracking and spalling at damn connections. Light honeycombing and alligator cracking around drain outlets.		
HYDROLOGY			
Water Velocity:	0.3 m/s	Ice Problem:	P - Possible Problem
Water Depth:	0.3 m	Scour Problem:	N - No Problem
Waterway:	01 - Adequate	Debris Problem:	P - Possible Problem
Comments:			
REPLACEMENT/REHABILITATION			
Next Rehab. Date:	2023	Replacement Year:	2040
Antic. Rehab. Cost:	\$0	Replacement Cost:	\$0
Recommendations:	Repair approach rails, concrete defects and cleanout expansion joints		
OBSERVATIONS			
Overall Condition:	F2 - Fair	Requires Further Inspection:	No

Additional Observations:	Mostly unchanged from previous inspection
