| | GOVERNMENT OF NEWFOUNDLAND AND LABRADOR Department of Transportation and Infrastructure | BRIDGE INSPECTION REPORT B03252022-1 | |
| Date: 3/10/2022 | Inspected By: Trevor Upshall | Category: Eng. - Engineering | |
| Site: | 1-073 - VITCH'S BRIDGE | | |

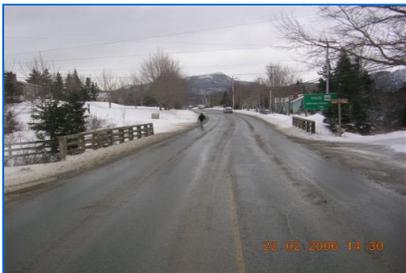
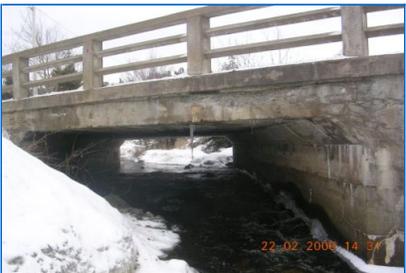
| Comments: | Light spalling/delamination to south frame leg. Narrow vertical cracks with light efflorescence deposits throughout frame legs. Medium spalling upstream wing wall. | | |

| Comments: | Structure does not have structural approach/exit guiderail. Hazard markers installed directly on aluminum handrail. North West curb/facia medium spalling with narrow cracks. Medium spalling near exposed reinforcement in deck soffit at numerous locations. Narrow cracks with light efflorescence deposits in deck soffit. | | |

| Recommendations: | Structure was rehabbed in 2017. | | |
