GOVERNMENT OF NEWFOUNDLAND AND LABRADOR Department of Transportation and Infrastructure	BRIDGE INSPECTION REPORT B11122021-1	
Date: 10/19/2021	Inspected By: Mike Button	Category: Office - Bridge Office	
BRIDGE INFORMATION			
Site:	1-083 - WESTERN BAY BROOK BRIDGE NO.1		
Route:		Overall Length:	25.8 m
Year Built:	1970	Est: No	Overall Width: 10.8 m
Year Last Rehab.:		Est: No	Roadway Width: 6.3 m
Region:	AVALON PENINSULA	Sidewalk Width:	0 m
Jurisdiction:	Provincial	Clearance to R.D. or N.W.L.:	6 m
Type of Structure:	02 - Double Tee	Max Depth of N.W.L.:	1 m
Purpose of Structure:	04 - Over Non-Navigable Waters	Spans:	
Type of Handrail:	04 - Steel Rail	Span No.:	Length
Roadway Surface:	02 - Asphalt	Span No.:	Length
Alignment Vertical:	01 - Good	1	10.6
Alignment Horizontal:	02 - Adequate	2	0
Restrictions:	No	3	0
		4	0
		5	0
		6	0
BRIDGE PHOTOS

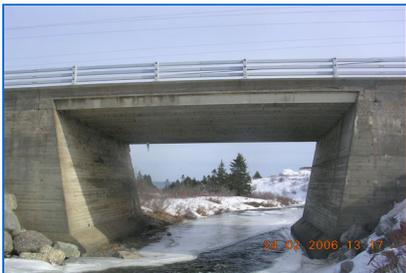
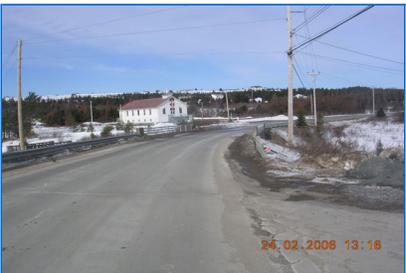
Bearing Seat:	F1 - Fair
Comments:	- South abutment has light vertical cracks with efflorescence on the south exterior corners. Light vertical cracking evident throughout the abutment face. Water slamming into the southwest corner of the south footing, suspect scour in this location. Area needs rip-rap. - North abutment has light scour and concrete disintegration on the northeast corner of the structure. Area is currently out of water. - All wingwalls in fair condition, northeast wingwall has mild map cracking. - Bearing seats showing no signs of spalling or leakage.		
SUPERSTRUCTURE			
Condition:	F1 - Fair	Expansion Joints:	F1 - Fair
Comments:	- South side of bridge is fixed, and the north is the expansion end. - No visible leakage on abutment faces, asphalt is cracked above on both the fixed and expansion ends, F1. - Double tees in fair condition, stirrups exposed on all double tees due to low cover. In some locations, rebar is also exposed on the bottom of the double

tee deck pre cast deck sections, F1. No leakage seen between pre-cast sections, indicating waterproofing and deck concrete above still in good condition.			
DECK			
Condition:	F1 - Fair	Curbs:	F1 - Fair
Hand Rail:	P3 - Poor	Roadway Condition:	F1 - Fair
Approach Rail:	F1 - Fair		
Comments:	- Asphalt has cracks over approaches, F1. - Guiderail has some split posts, rails are not connected to end blocks and all hazard markers are in place. No additional energy dampening posts at end blocks, F1. - Interior curbs have minor cracks throughout, especially around expansion joints, F1. - Exterior curb/fascia in also in fair condition. No chaulking over curb joint to structure. The east side has mild cracking with efflorescence near mid span. - Handrails have medium to severe corrosion throughout some minor denting/bends. Ends of rails are encased in end block concrete with rusty water slurry leaking from the encasement connection. Some rails are corroded through in this location P3. Some posts have also corroded through near the bottoms, P3.

HYDROLOGY			
Water Velocity:	0.4 m/s	Ice Problem:	N - No Problem
Water Depth:	0.8 m	Scour Problem:	P - Possible Problem
Waterway:	02 - InAdequate	Debris Problem:	N - No Problem
Comments:	- Water is slamming into southwest corner of the south footing, scour is suspected. Structure is misaligned to river and seems narrow for the flow rate.		
REPLACEMENT/REHABILITATION			
Next Rehab. Date:	2024	Replacement Year:	2035
Antic. Rehab. Cost:	\$30,000	Replacement Cost:	\$1,300,000
Recommendations:	- Replace handrail and pour back areas where handrails are to be removed from end blocks. Place rip-rap on southwest corner, river slamming into area. Remove road sand/gravel from curbs. Reseal/chaulk curbs over the bearing seats.		
OBSERVATIONS			
Overall Condition:	F1 - Fair	Requires Further Inspection:	No
Additional Observations:	- Hazards, medium traffic and steep slopes.
