GOVERNMENT OF NEWFOUNDLAND AND LABRADOR Department of Transportation and Works	<b>BRIDGE INSPECTION REPORT</b> <b>B07302018-4</b> Printed: Tuesday, October 2, 2018	
<b>Date:</b> 7/23/2018	<b>Inspected By:</b> Parsons R	<b>Category:</b> Maint. - Maintenance	
<b>BRIDGE INFORMATION</b>			
<b>Site:</b>	1-083 - WESTERN BAY BROOK BRIDGE NO.1		
<b>Route:</b>		<b>Overall Length:</b>	25.8 m
<b>Year Built:</b>	1970	<b>Est:</b> No	<b>Overall Width:</b> 10.8 m
<b>Year Last Rehab.:</b>		<b>Est:</b> No	<b>Roadway Width:</b> 6.3 m
<b>Region:</b>	AVALON PENINSULA	<b>Sidewalk Width:</b>	0 m
<b>Jurisdiction:</b>	Provincial	<b>Clearance to R.D. or N.W.L.:</b>	6 m
<b>Type of Structure:</b>	02 - Double Tee	<b>Max Depth of N.W.L.:</b>	1 m
<b>Purpose of Structure:</b>	04 - Over Non-Navigable Waters	<b>Spans:</b>	
<b>Type of Handrail:</b>	04 - Steel Rail	<u>Span No.:</u>	<u>Length</u>
<b>Roadway Surface:</b>	02 - Asphalt	<u>Span No.:</u>	<u>Length</u>

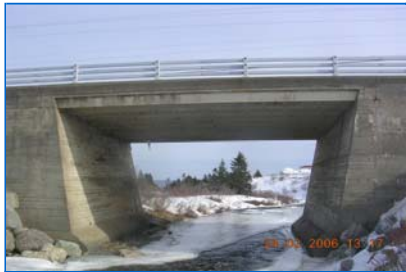
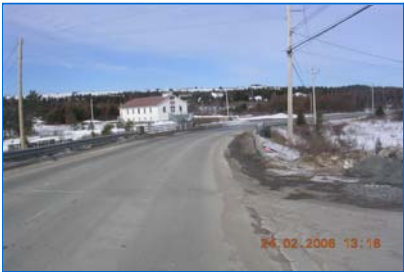
<b>SUBSTRUCTURE</b>			
<b>Condition:</b>	F2 - Fair (Inspection within 2 Years)	<b>Bearings:</b>	G - Good (Inspection within 2 Years)
		<b>Bearing Seat:</b>	G - Good (Inspection within 2 Years)
<b>Comments:</b>	- Some scouring of footings and undermining.		
<b>SUPERSTRUCTURE</b>			
<b>Condition:</b>	F2 - Fair (Inspection within 2 Years)	<b>Expansion Joints:</b>	F2 - Fair (Inspection within 2 Years)
<b>Comments:</b>	- Expansion joints paved over. - Beams in good shape. - Cracks over expansion joints.		
<b>DECK</b>			
<b>Condition:</b>	F2 - Fair (Inspection within 2 Years)	<b>Curbs:</b>	F2 - Fair (Inspection within 2 Years)
<b>Hand Rail:</b>	F1 - Fair (Inspection within 1 Year)	<b>Roadway Condition:</b>	F2 - Fair (Inspection within 2 Years)

<b>Approach Rail:</b>	G - Good (Inspection within 2 Years)		
<b>Comments:</b>	- Deterioration of curbs and rail footings. - Rails rusted and in poor shape.		
<b>HYDROLOGY</b>			
<b>Water Velocity:</b>	0 m/s	<b>Ice Problem:</b>	P - Possible Problem
<b>Water Depth:</b>	1.0 m	<b>Scour Problem:</b>	K - Known Problem
<b>Waterway:</b>	01 - Adequate	<b>Debris Problem:</b>	P - Possible Problem
<b>Comments:</b>			
<b>REPLACEMENT/REHABILITATION</b>			
<b>Next Rehab. Date:</b>	2018	<b>Replacement Year:</b>	2018
<b>Antic. Rehab. Cost:</b>	\$0.00	<b>Replacement Cost:</b>	\$0.00
<b>Recommendations:</b>			
<b>OBSERVATIONS</b>			
<b>Overall Condition:</b>	F2 - Fair (Inspection within 2 Years)	<b>Requires Further Inspection:</b>	Yes
<b>Additional Observations:</b>	- Rail and rail footings need to be looked at. - Good candidate for rehab.		
<b>LEGEND:</b>			
<b>Condition Definitions:</b>			
1 - *Good - [discontinued code].	F2 - Fair (Inspection within 2 Years).	C - Unsafe (Closed to Public).	<b>Problem Definitions:</b>
