GOVERNMENT OF NEWFOUNDLAND AND LABRADOR Department of Transportation and Infrastructure	<b>BRIDGE INSPECTION REPORT</b> <b>B07262021-11</b>	
<b>Date:</b> 7/5/2021	<b>Inspected By:</b> Justine Geddes	<b>Category:</b> Office - Bridge Office	
<b>BRIDGE INFORMATION</b>			
<b>Site:</b>	3-021 - BARBOUR'S TICKLE BRIDGE		
<b>Route:</b>		<b>Overall Length:</b>	35.1 m
<b>Year Built:</b>	1965	<b>Est:</b> No	<b>Overall Width:</b> 9 m
<b>Year Last Rehab.:</b>		<b>Est:</b> No	<b>Roadway Width:</b> 7.3 m
<b>Region:</b>	CENTRAL WEST	<b>Sidewalk Width:</b>	0 m
<b>Jurisdiction:</b>	Provincial	<b>Clearance to R.D. or N.W.L.:</b>	4.5 m
<b>Type of Structure:</b>	01 - AASH to Girder	<b>Max Depth of N.W.L.:</b>	3 m
<b>Purpose of Structure:</b>	03 - Over Navigable Waters	<b>Spans:</b>	
<b>Type of Handrail:</b>	02 - Concrete Rail	<u>Span No.:</u>	<u>Length</u>
<b>Roadway Surface:</b>	02 - Asphalt	1	23.6
<b>Alignment Vertical:</b>	01 - Good	2	0

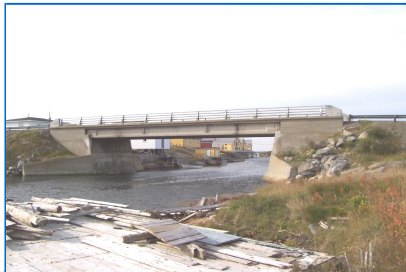
<b>SUBSTRUCTURE</b>			
<b>Condition:</b>	F1 - Fair	<b>Bearings:</b>	F1 - Fair
		<b>Bearing Seat:</b>	F1 - Fair
<b>Comments:</b>	generally ok, some surface cracking in wingwalls,		
<b>SUPERSTRUCTURE</b>			
<b>Condition:</b>	F1 - Fair	<b>Expansion Joints:</b>	U - Uninspectable
<b>Comments:</b>	Joints paved over, small concrete spall at one end by curbs.		
<b>DECK</b>			
<b>Condition:</b>	F1 - Fair	<b>Curbs:</b>	F1 - Fair
<b>Hand Rail:</b>	F1 - Fair	<b>Roadway Condition:</b>	F1 - Fair

<b>Approach Rail:</b>	F1 - Fair		
<b>Comments:</b>	Appears to have had overlay. Curbs starting to show signs of rusting, end block has been hit. will need to be repaved and waterproofed in ten years or so.		
<b>HYDROLOGY</b>			
<b>Water Velocity:</b>	tidal m/s	<b>Ice Problem:</b>	N - No Problem
<b>Water Depth:</b>	deep m	<b>Scour Problem:</b>	P - Possible Problem
<b>Waterway:</b>	01 - Adequate	<b>Debris Problem:</b>	N - No Problem
<b>Comments:</b>	water too deep to see if scour is an issue, low risk structure for this as water slow.		
<b>REPLACEMENT/REHABILITATION</b>			
<b>Next Rehab. Date:</b>	2030	<b>Replacement Year:</b>	2055
<b>Antic. Rehab. Cost:</b>	\$200000	<b>Replacement Cost:</b>	\$5000000
<b>Recommendations:</b>	in ten years: paving, waterproofing, curbs, end blocks, steel rail , small areas latex modified		
<b>OBSERVATIONS</b>			
<b>Overall Condition:</b>	F1 - Fair	<b>Requires Further Inspection:</b>	No
