GOVERNMENT OF NEWFOUNDLAND AND LABRADOR Department of Transportation and Infrastructure	BRIDGE INSPECTION REPORT B07162021-8	
Date: 7/9/2021	Inspected By: McCaw J	Category: Eng. - Engineering	
BRIDGE INFORMATION			
Site:	3-172 - BUNDLES BROOK BRIDGE		
Route:	1	Overall Length:	0 m
Year Built:	1950	Est: Yes	Overall Width: 0 m
Year Last Rehab.:		Est: No	Roadway Width: 0 m
Region:	CENTRAL WEST	Sidewalk Width:	0 m
Jurisdiction:	Provincial	Clearance to R.D. or N.W.L.:	0 m
Type of Structure:	04 - Rigid Frame	Max Depth of N.W.L.:	0 m
Purpose of Structure:	04 - Over Non-Navigable Waters		
Type of Handrail:	02 - Concrete Rail	Spans:	
Roadway Surface:	02 - Asphalt	<u>Span No.:</u>	<u>Length</u>
Alignment Vertical:	01 - Good	1	0
Alignment Horizontal:	01 - Good	2	0
Restrictions:	Yes	3	0
Describe Restrictions:	On class 4 Road.		
BRIDGE PHOTOS

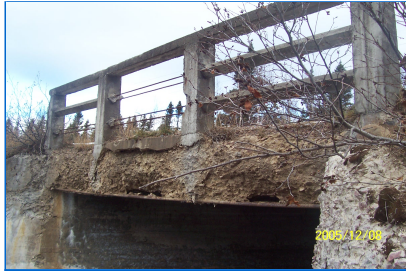
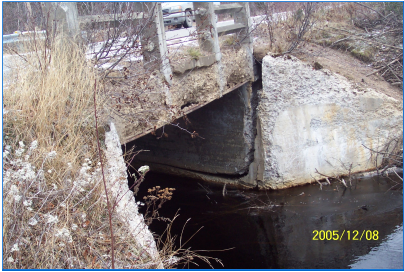
SUBSTRUCTURE			
Condition:	P1 - Poor	Bearings:	I - Inapplicable
		Bearing Seat:	I - Inapplicable

Comments:	Significant eroding of concrete at waterline. Large crack between abutment and upstream wingwall.		
SUPERSTRUCTURE			
Condition:	P1 - Poor	Expansion Joints:	I - Inapplicable
Comments:	Outside girders spalled significantly. Rebar is fully exposed.		
DECK			
Condition:	P - Poor	Curbs:	P - Poor
Hand Rail:	P - Poor	Roadway Condition:	P - Poor

Approach Rail:	P - Poor		
Comments:	P-Edges of deck, F1 - Remainder. Cracking on road surface. Concrete rails and guiderail in poor condition with missing sections and tipping posts.		
HYDROLOGY			
Water Velocity:	0.05 m/s	Ice Problem:	N - No Problem
Water Depth:	0.4 m	Scour Problem:	N - No Problem
Waterway:	01 - Adequate	Debris Problem:	N - No Problem
Comments:			
REPLACEMENT/REHABILITATION			
Next Rehab. Date:	2021	Replacement Year:	2023
Antic. Rehab. Cost:	\$0	Replacement Cost:	\$500000
Recommendations:	Not economical to rehabilitate structure. Recommend replacement with culvert or arch.		
OBSERVATIONS			
Overall Condition:	P - Poor	Requires Further Inspection:	No
Additional Observations:	hazards: traffic, water, slipping. Does not appear to be a maintained structure.		
LEGEND:			
Condition Definitions:		Problem Definitions:	
1 - *Good - [discontinued code].	F2 - Fair.	C - Unsafe (Closed to Public).	N - No Problem.
