GOVERNMENT OF NEWFOUNDLAND AND LABRADOR Department of Transportation and Infrastructure	BRIDGE INSPECTION REPORT B01202020-59	
Date: 9/24/2019	Inspected By: Lynch R / Martin L	Category: Eng. - Engineering	
BRIDGE INFORMATION			
Site:	3-044 - DARK COVE TICKLE BRIDGE, BRIGHTON		
Route:		Overall Length:	28.2 m
Year Built:	1991	Est: No	Overall Width: 9.6 m
Year Last Rehab.:		Est: No	Roadway Width: 8.6 m
Region:	CENTRAL WEST	Sidewalk Width:	0 m
Jurisdiction:	Provincial	Clearance to R.D. or N.W.L.:	2.5 m
Type of Structure:	01 - AASH to Girder	Max Depth of N.W.L.:	2.5 m
Purpose of Structure:	03 - Over Navigable Waters	Spans:	
Type of Handrail:	01 - Aluminum Rail	<u>Span No.:</u>	<u>Length</u>
Roadway Surface:	02 - Asphalt	1	16.8
Alignment Vertical:	01 - Good	2	0
Alignment Horizontal:	01 - Good	3	0
Restrictions:	No	<u>Span No.:</u>	<u>Length</u>
		4	0
		5	0
		6	0
BRIDGE PHOTOS

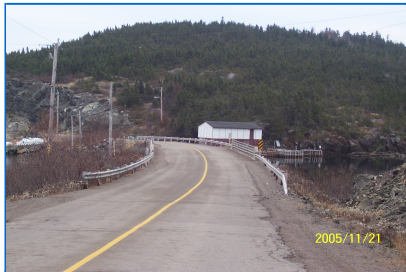
Bearing Seat:	F2 - Fair
Comments:	Bearings at abutment 2 in slight shear. Narrow vertical cracks in both abutments.		
SUPERSTRUCTURE			
Condition:	F2 - Fair	Expansion Joints:	F1 - Fair
Comments:	Joint dams damaged with missing concrete, curbs missing concrete as well. Joints rusty with scaling and full of winter sand but no evidence of leaking.		
DECK			
Condition:	F2 - Fair	Curbs:	F2 - Fair
Hand Rail:	F2 - Fair	Roadway Condition:	F2 - Fair

Approach Rail:	F1 - Fair		
Comments:	Potholes in deck and approaches at expansion joints. Curbs have spalling - rebar exposed at expansion joint 2; RHS. Plow damage on all guiderail with broken / rotten posts.		
HYDROLOGY			
Water Velocity:	0 m/s	Ice Problem:	N - No Problem
Water Depth:	0 m	Scour Problem:	N - No Problem
Waterway:	01 - Adequate	Debris Problem:	N - No Problem
Comments:	No navigation lights.		
REPLACEMENT/REHABILITATION			
Next Rehab. Date:		Replacement Year:	
Antic. Rehab. Cost:	\$0	Replacement Cost:	\$0
Recommendations:	Replace guiderail, repair curbs, asphalt and joint dams. Install navigation lights.		
OBSERVATIONS			
Overall Condition:	F2 - Fair	Requires Further Inspection:	No
Additional Observations:			
LEGEND:			
Condition Definitions:		Problem Definitions:	
1 - *Good - [discontinued code].	F2 - Fair.	C - Unsafe (Closed to Public).	N - No Problem.
2 - *Fair - [discontinued code].	F1 - Fair.	U - Uninspectable.	P - Possible Problem.
