GOVERNMENT OF NEWFOUNDLAND AND LABRADOR Department of Transportation and Infrastructure	<b>BRIDGE INSPECTION REPORT</b> <b>B01162020-7</b>	
<b>Date:</b> 8/21/2019	<b>Inspected By:</b> Lynch R / Martin L	<b>Category:</b> Eng. - Engineering	
<b>BRIDGE INFORMATION</b>			
<b>Site:</b>	3-084 - GREENSPOND TICKLE CAUSEWAY BRIDGE		
<b>Route:</b>		<b>Overall Length:</b>	64.9 m
<b>Year Built:</b>	1984	<b>Est:</b> No	<b>Overall Width:</b> 0 m
<b>Year Last Rehab.:</b>		<b>Est:</b> No	<b>Roadway Width:</b> 8.6 m
<b>Region:</b>	CENTRAL WEST		<b>Sidewalk Width:</b> 0 m
<b>Jurisdiction:</b>	Provincial		<b>Clearance to R.D. or N.W.L.:</b> 5.6 m
<b>Type of Structure:</b>	01 - AASH to Girder		<b>Max Depth of N.W.L.:</b> 2.2 m
<b>Purpose of Structure:</b>	03 - Over Navigable Waters		<b>Spans:</b>
<b>Type of Handrail:</b>	01 - Aluminum Rail		<u>Span No.:</u> <u>Length</u> <u>Span No.:</u> <u>Length</u>
<b>Roadway Surface:</b>	01 - Concrete	1	41.4   4   0

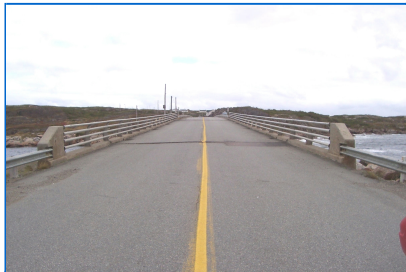
<b>SUBSTRUCTURE</b>			
<b>Condition:</b>	F2 - Fair	<b>Bearings:</b>	P3 - Poor
		<b>Bearing Seat:</b>	F2 - Fair
<b>Comments:</b>	Hairline cracks in abutments and back walls. Bearings at all girders, both sides, fatigued with large cracks and disintegration.		
<b>SUPERSTRUCTURE</b>			
<b>Condition:</b>	F2 - Fair	<b>Expansion Joints:</b>	P3 - Poor
<b>Comments:</b>	Expansion joints paved over; no joint present in curb, just a gap. Extra layer of asphalt on deck. Expansion joints are leaking. Minor spalls with rebar exposed and staining on girder #'s 1, 4 and 5. All diaphragms on abutment #1 have cracks at the bottom.		
<b>DECK</b>			
<b>Condition:</b>	F2 - Fair	<b>Curbs:</b>	F2 - Fair

<b>Hand Rail:</b>	F2 - Fair	<b>Roadway Condition:</b>	F2 - Fair
<b>Approach Rail:</b>	F2 - Fair		
<b>Comments:</b>	No buried end on exit of abutment #1. Double layer of asphalt on deck. Some spalling and delamination on curbs. No terminal ends on guide rail. Potholes and patches at expansion joints due to settlement.

<b>Next Rehab. Date:</b>		<b>Replacement Year:</b>	
<b>Antic. Rehab. Cost:</b>	\$0	<b>Replacement Cost:</b>	\$0
<b>Recommendations:</b>	Replace expansion joints. Repair navigation lights. Install buried end. Clean deck and drains.
