GOVERNMENT OF NEWFOUNDLAND AND LABRADOR Department of Transportation and Infrastructure	BRIDGE INSPECTION REPORT B08032021-10	
Date: 7/5/2021	Inspected By: Justine Geddes	Category: Office - Bridge Office	
BRIDGE INFORMATION			
Site:	3-003 - HORWOOD RIVER BRIDGE		
Route:		Overall Length:	24 m
Year Built:	1976	Est: No	Overall Width: 10.2 m
Year Last Rehab.:		Est: No	Roadway Width: 9 m
Region:	CENTRAL WEST	Sidewalk Width:	0 m
Jurisdiction:	Provincial	Clearance to R.D. or N.W.L.:	1.5 m
Type of Structure:	02 - Double Tee	Max Depth of N.W.L.:	2 m
Purpose of Structure:	04 - Over Non-Navigable Waters	Spans:	
Type of Handrail:	01 - Aluminum Rail	<u>Span No.:</u>	<u>Length</u>
Roadway Surface:	02 - Asphalt	1	15
Alignment Vertical:	01 - Good	2	0
Alignment Horizontal:	01 - Good	3	0
Restrictions:	No	Span No.:	Length
		4	0
		5	0
		6	0
BRIDGE PHOTOS

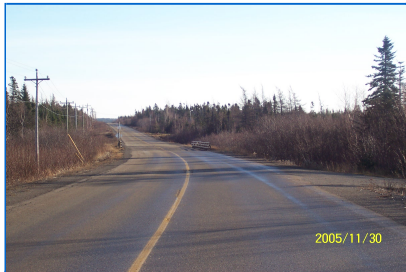
Comments:	Recent rehabilitation to abutments		
SUPERSTRUCTURE			
Condition:	F1 - Fair	Expansion Joints:	F1 - Fair
Comments:	Double Tees starting to have shear steel show, small areas of deck edge spalling, no curbs		
DECK			
Condition:	F2 - Fair	Curbs:	I - Inapplicable
Hand Rail:	G - Good	Roadway Condition:	I - Inapplicable
