GOVERNMENT OF NEWFOUNDLAND AND LABRADOR Department of Transportation and Infrastructure	<b>BRIDGE INSPECTION REPORT</b> <b>B01172020-7</b>	
<b>Date:</b> 9/26/2019	<b>Inspected By:</b> Lynch R / Martin L	<b>Category:</b> Eng. - Engineering	
<b>BRIDGE INFORMATION</b>			
<b>Site:</b>	3-028 - LITTLE SANDY BROOK BRIDGE		
<b>Route:</b>	370	<b>Overall Length:</b>	12.8 m
<b>Year Built:</b>	1969	<b>Est:</b> No	<b>Overall Width:</b> 9 m
<b>Year Last Rehab.:</b>		<b>Est:</b> No	<b>Roadway Width:</b> 7.4 m
<b>Region:</b>	CENTRAL WEST	<b>Sidewalk Width:</b>	0 m
<b>Jurisdiction:</b>	Provincial	<b>Clearance to R.D. or N.W.L.:</b>	2.5 m
<b>Type of Structure:</b>	02 - Double Tee	<b>Max Depth of N.W.L.:</b>	0.5 m
<b>Purpose of Structure:</b>	04 - Over Non-Navigable Waters		<b>Spans:</b>
<b>Type of Handrail:</b>	01 - Aluminum Rail	<u>Span No.:</u>	<u>Length</u>
<b>Roadway Surface:</b>	02 - Asphalt	1	10
<b>Alignment Vertical:</b>	01 - Good	2	0

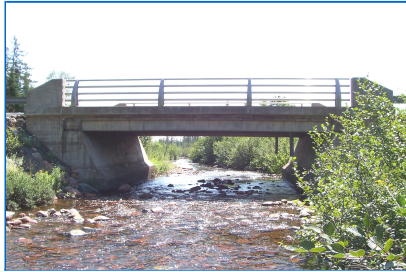
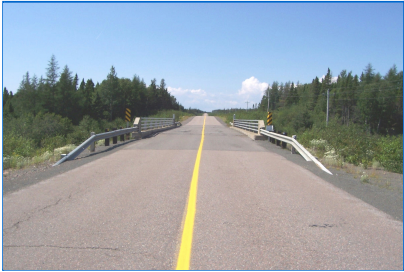
<b>SUBSTRUCTURE</b>			
<b>Condition:</b>	F2 - Fair	<b>Bearings:</b>	I - Inapplicable
		<b>Bearing Seat:</b>	F2 - Fair
<b>Comments:</b>	Minor spalling on abutments. Repairs to footing undermining good. Creep blocks have wide cracks.		
<b>SUPERSTRUCTURE</b>			
<b>Condition:</b>	F2 - Fair	<b>Expansion Joints:</b>	F2 - Fair
<b>Comments:</b>	Wide cracks in center double tees at abutment 1 on bottoms of webs. Deck sides and soffit have narrow to wide cracking.		
<b>DECK</b>			
<b>Condition:</b>	F2 - Fair	<b>Curbs:</b>	F2 - Fair
<b>Hand Rail:</b>	F2 - Fair	<b>Roadway Condition:</b>	F2 - Fair

<b>Approach Rail:</b>	F2 - Fair		
<b>Comments:</b>	Newly paved, joints paved over but not a single crack. Minor damage to approach rail on LHS abutment 2.		
<b>HYDROLOGY</b>			
<b>Water Velocity:</b>	0 m/s	<b>Ice Problem:</b>	N - No Problem
<b>Water Depth:</b>	0 m	<b>Scour Problem:</b>	N - No Problem
<b>Waterway:</b>	01 - Adequate	<b>Debris Problem:</b>	N - No Problem
<b>Comments:</b>			
<b>REPLACEMENT/REHABILITATION</b>			
<b>Next Rehab. Date:</b>		<b>Replacement Year:</b>	
<b>Antic. Rehab. Cost:</b>	\$0	<b>Replacement Cost:</b>	\$0
<b>Recommendations:</b>	Repair deformed buried end on LHS abutment 2. Clean winter sand from bridge.		
<b>OBSERVATIONS</b>			
<b>Overall Condition:</b>	F2 - Fair	<b>Requires Further Inspection:</b>	No
<b>Additional Observations:</b>			
<b>LEGEND:</b>			
<b>Condition Definitions:</b>			
1 - *Good - [discontinued code].	F2 - Fair.	C - Unsafe (Closed to Public).	<b>Problem Definitions:</b>
