GOVERNMENT OF NEWFOUNDLAND AND LABRADOR Department of Transportation and Infrastructure	<b>BRIDGE INSPECTION REPORT</b> <b>B07152021-2</b>																	
<b>Date:</b> 7/6/2021	<b>Inspected By:</b> McCaw J	<b>Category:</b> Eng. - Engineering																	
<b>BRIDGE INFORMATION</b>																			
<b>Site:</b>	3-073 - MILL BROOK BRIDGE, PT. LEAMINGTON																		
<b>Route:</b>	350	<b>Overall Length:</b>	25.9 m																
<b>Year Built:</b>	1978	<b>Est:</b> No	<b>Overall Width:</b> 0 m																
<b>Year Last Rehab.:</b>		<b>Est:</b> No	<b>Roadway Width:</b> 8 m																
<b>Region:</b>	CENTRAL WEST	<b>Sidewalk Width:</b>	0 m																
<b>Jurisdiction:</b>	Provincial	<b>Clearance to R.D. or N.W.L.:</b>	3.5 m																
<b>Type of Structure:</b>	02 - Double Tee	<b>Max Depth of N.W.L.:</b>	1.5 m																
<b>Purpose of Structure:</b>	04 - Over Non-Navigable Waters																		
<b>Type of Handrail:</b>	01 - Aluminum Rail																		
<b>Roadway Surface:</b>	02 - Asphalt

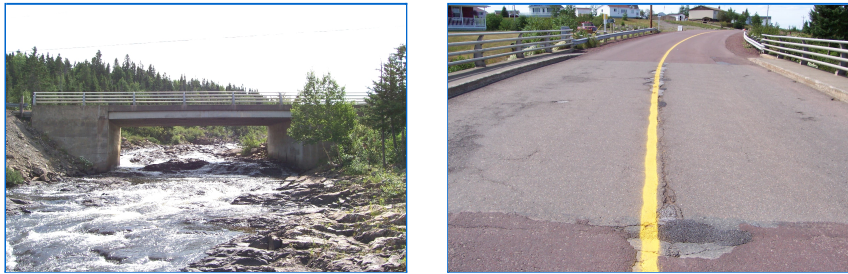
<b>SUBSTRUCTURE</b>																			
<b>Condition:</b>	F2 - Fair	<b>Bearings:</b>	I - Inapplicable																
		<b>Bearing Seat:</b>	F2 - Fair																
<b>Comments:</b>	Wingwalls have significant efflor. Curtain wall spalling on NE end. Significant erosion around wingwalls. Cracks in upstream wingwalls.																		
<b>SUPERSTRUCTURE</b>																			
<b>Condition:</b>	F2 - Fair	<b>Expansion Joints:</b>	P1 - Poor																
<b>Comments:</b>	Some leaking through double tees. Expansion joints filled or covered with asphalt.																		
<b>DECK</b>																			
<b>Condition:</b>	P3 - Poor	<b>Curbs:</b>	P3 - Poor																
<b>Hand Rail:</b>	F2 - Fair	<b>Roadway Condition:</b>	P3 - Poor

<b>Approach Rail:</b>	P3 - Poor		
<b>Comments:</b>	Asphalt needs to be removed and replaced. Numerous patches, deck visible, curbs and sidewalks damaged.		
<b>HYDROLOGY</b>			
<b>Water Velocity:</b>	1.5 m/s	<b>Ice Problem:</b>	N - No Problem
<b>Water Depth:</b>	0.5 m	<b>Scour Problem:</b>	K - Known Problem
<b>Waterway:</b>	01 - Adequate	<b>Debris Problem:</b>	N - No Problem
<b>Comments:</b>	Significant erosion around S side wingwall. Scour visible under footings.		
<b>REPLACEMENT/REHABILITATION</b>			
<b>Next Rehab. Date:</b>	2022	<b>Replacement Year:</b>	2040
<b>Antic. Rehab. Cost:</b>	\$250000	<b>Replacement Cost:</b>	\$3000000
<b>Recommendations:</b>	Correct erosion in near future. Remove asphalt, repair deck, repair curbs. Install new end blocks and steel rail. Install new guiderail -structures. May require gabion walls to reduce slopes around wingwalls. Repair wingwalls and curtain walls. Install new deck drains and replace expansion joints.

<b>OBSERVATIONS</b>			
<b>Overall Condition:</b>	P3 - Poor	<b>Requires Further Inspection:</b>	No
<b>Additional Observations:</b>	P1 - Erosion around wingwalls. P3 - Decks wingwalls. A small waterline has been installed by locals on downstream side. Does not appear to be a municipal line. Parking ok. Hazards: Traffic, Slipping, Water		
<b>LEGEND:</b>			
<b>Condition Definitions:</b>		<b>Problem Definitions:</b>	
1 - *Good - [discontinued code].	F2 - Fair.	C - Unsafe (Closed to Public).	N - No Problem.
2 - *Fair - [discontinued code].	F1 - Fair.	U - Uninspectable.	P - Possible Problem.
3 - *Poor - [discontinued code].	P3 - Poor.	I - Inapplicable.	K - Known Problem.
4 - *Unsafe - [discontinued code].	P1 - Poor.		NA - Not Applicable.
G - Good.	P - Poor.		
<b>Category Definitions:</b>			
Maint. - Maintenance.			
Eng. - Engineering.			
Office - Bridge Office.			
<b>PHOTO GUIDELINES:</b>			
<b>Inspection Photos:</b>
