GOVERNMENT OF NEWFOUNDLAND AND LABRADOR Department of Transportation and Infrastructure	BRIDGE INSPECTION REPORT B09162021-8	
Date: 9/2/2021	Inspected By: Mike Button	Category: Office - Bridge Office	
BRIDGE INFORMATION			
Site:	3-063 - ST. JOSEPH'S COVE BRIDGE		
Route:	361	Overall Length:	25.9 m
Year Built:	1973	Est: No	Overall Width: 10.3 m
Year Last Rehab.:		Est: No	Roadway Width: 8.8 m
Region:	CENTRAL WEST	Sidewalk Width:	0 m
Jurisdiction:	Provincial	Clearance to R.D. or N.W.L.:	3.5 m
Type of Structure:	01 - AASH to Girder	Max Depth of N.W.L.:	1 m
Purpose of Structure:	04 - Over Non-Navigable Waters	Spans:	
Type of Handrail:	02 - Concrete Rail	Span No.:	Length
Roadway Surface:	02 - Asphalt	1	16
Alignment Vertical:	01 - Good	2	0
Alignment Horizontal:	02 - Adequate	3	0
Restrictions:	No	Span No.:	Length
		4	0
		5	0
		6	0
BRIDGE PHOTOS

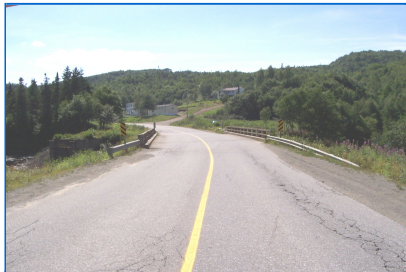
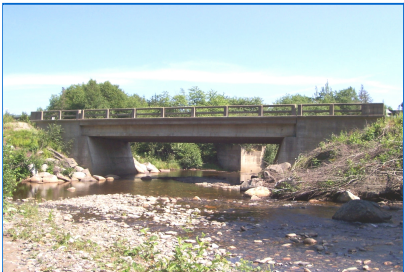
Bearing Seat:	P3 - Poor
Comments:	- All wingwall concrete in fair condition. Some mild-medium erosion/undermining of northeast wingwall. - South abutment exterior bearing areas has vegetation growth due to curb leakage above, mostly likely through un-chalked curbs, expansion joints appear to be ok. River side face of the south abutment has no visible cracking with some light scour at the bedrock/footing joint. - North abutment river side face has no visible scour but has mild erosion to concrete at the waterline. No visible cracking. Northeast bearing area has a large wide crack on the corner of the abutment likely caused by un-chalked curb above, P3. Monitor crack for a spall on future inspections for undermining the girder. Bearing seats and pads too high for inspection.		
SUPERSTRUCTURE			
Condition:	F2 - Fair	Expansion Joints:	F2 - Fair
Comments:	- Underside of deck above the northeast bearing area has a medium size spall caused by un-chalked curb, P3. Remainder of the underside of deck, F2. - Girders in fair condition, F2. - Expansion joints have no visible sign of

Condition:	F1 - Fair	Curbs:	P3 - Poor
Hand Rail:	P3 - Poor	Roadway Condition:	P3 - Poor
Approach Rail:	F1 - Fair		
Comments:	- Asphalt has medium cracking and pot holes, P3. - Approach/exit rails have mild damage, and have hazard markers in place. Rails not attached to end blocks, F1. - Curbs have medium spalling and light cracking throughout F1, P3 in joints because curbs are not chaulked. - West fascia/soffit in fair condition, F2. - East fascia/soffit has medium cracking with efflorescence on the southeast side, P3. Northeast deck drain area has a large spall with heavy corrosion, P3. - Handrails P3, old concrete handrail, small-medium spalls and cracking with efflorescence in some locations, F1 in others.

Water Velocity:	0.3 m/s	Ice Problem:	N - No Problem
Water Depth:	0.3 m	Scour Problem:	P - Possible Problem
Waterway:	01 - Adequate	Debris Problem:	N - No Problem
Comments:	- Mild scour on south abutment. Rip rap mostly migrated into channel.

Next Rehab. Date:	2025	Replacement Year:	2035
Antic. Rehab. Cost:	\$100000	Replacement Cost:	\$1600000
Recommendations:	- Chaulk all curbs to prevent deterioration to bearing seats below. - Repair all bearing areas. - Re-locate rip-rap to corners of structure.
