| | GOVERNMENT OF NEWFOUNDLAND AND LABRADOR Department of Transportation and Infrastructure | BRIDGE INSPECTION REPORT B07262021-1 | |
| Date: 7/7/2021 | Inspected By: McCaw J | Category: Eng. - Engineering | |
| Site: | 3-094 - TRIMMS BROOK, MING'S BIGHT | | |

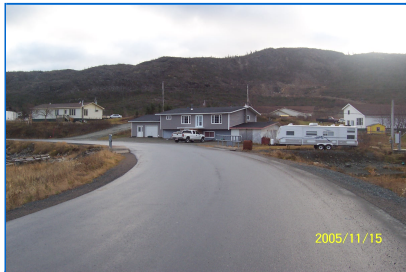
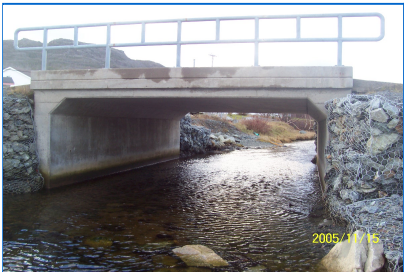
| Comments: | Gabions F2, Remainder G. Need to regularly inspect gabions as they appear to be leaning. | | |

| Comments: | Approaches are settling and road is cracking at edges of frame | | |
