GOVERNMENT OF NEWFOUNDLAND AND LABRADOR Department of Transportation and Infrastructure	BRIDGE INSPECTION REPORT B07262021-13	
Date: 7/5/2021	Inspected By: Justine Geddes	Category: Office - Bridge Office	
BRIDGE INFORMATION			
Site:	3-059 - WINDMILL BROOK BRIDGE #2 NORTH		
Route:		Overall Length:	23.4 m
Year Built:	1967	Est: No	Overall Width: 10.2 m
Year Last Rehab.:	1985	Est: No	Roadway Width: 9 m
Region:	CENTRAL WEST	Sidewalk Width:	0 m
Jurisdiction:	Provincial	Clearance to R.D. or N.W.L.:	2.5 m
Type of Structure:	02 - Double Tee	Max Depth of N.W.L.:	2 m
Purpose of Structure:	04 - Over Non-Navigable Waters	Spans:	
Type of Handrail:	01 - Aluminum Rail	<u>Span No.:</u>	<u>Length</u>
Roadway Surface:	02 - Asphalt	1	15.9
Alignment Vertical:	01 - Good	2	0
Alignment Horizontal:	01 - Good	3	0
Restrictions:	No	Span No.:	Length
		4	0
		5	0
		6	0
BRIDGE PHOTOS

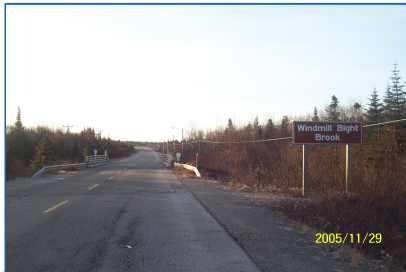
Bearing Seat:	F1 - Fair
Comments:	some small areas of concrete spall		
SUPERSTRUCTURE			
Condition:	P3 - Poor	Expansion Joints:	U - Uninspectable
Comments:	curbs and deck edges eroding away, edge double tees with significant concrete spall and rusting pretensioning strands at ends. interior Double Tees in generally fair condition. expansion joints if exist are paved over.		
DECK			
Condition:	P3 - Poor	Curbs:	P1 - Poor
Hand Rail:	P3 - Poor	Roadway Condition:	P1 - Poor

Approach Rail:	P3 - Poor		
Comments:	curbs extremely spalled and losing support to rail and end blocks.		
HYDROLOGY			
Water Velocity:	slow m/s	Ice Problem:	N - No Problem
Water Depth:	1-2 m	Scour Problem:	P - Possible Problem
Waterway:	02 - InAdequate	Debris Problem:	N - No Problem
Comments:	bridge pinches river, suspect will need to be wider for 100 year plus climate change flood waters. possible scour under north footing		
REPLACEMENT/REHABILITATION			
Next Rehab. Date:	2021	Replacement Year:	2023
Antic. Rehab. Cost:	\$0	Replacement Cost:	\$1500000
Recommendations:	replace by 2025. May need to reduce to one lane temporarily if deck edges continue to degrade.		
OBSERVATIONS			
Overall Condition:	P3 - Poor	Requires Further Inspection:	No
Additional Observations:	good visibility for traffic and wide enough shoulder to park truck mainly off road. fairly easy to get down all 4 corners, can only get under bridge on south side. hazards: traffic, slipping, stinging plants.
