GOVERNMENT OF NEWFOUNDLAND AND LABRADOR Department of Transportation and Infrastructure	<b>BRIDGE INSPECTION REPORT</b> <b>B08022021-7</b>	
<b>Date:</b> 5/6/2021	<b>Inspected By:</b> Butler	<b>Category:</b> Eng. - Engineering	
<b>BRIDGE INFORMATION</b>			
<b>Site:</b>	2-034 - BLACK RIVER BRIDGE		
<b>Route:</b>	210	<b>Overall Length:</b>	62.2 m
<b>Year Built:</b>	1968	<b>Est:</b> No	<b>Overall Width:</b> 11.6 m
<b>Year Last Rehab.:</b>	2007	<b>Est:</b> No	<b>Roadway Width:</b> 10.2 m
<b>Region:</b>	CENTRAL EAST	<b>Sidewalk Width:</b>	0 m
<b>Jurisdiction:</b>	Provincial	<b>Clearance to R.D. or N.W.L.:</b>	6.5 m
<b>Type of Structure:</b>	01 - AASH to Girder	<b>Max Depth of N.W.L.:</b>	1 m
<b>Purpose of Structure:</b>	04 - Over Non-Navigable Waters		
<b>Type of Handrail:</b>	01 - Aluminum Rail	<b>Spans:</b>	
<b>Roadway Surface:</b>	02 - Asphalt	<u>Span No.:</u>	<u>Length</u>
<b>Alignment Vertical:</b>	01 - Good	1	46.2

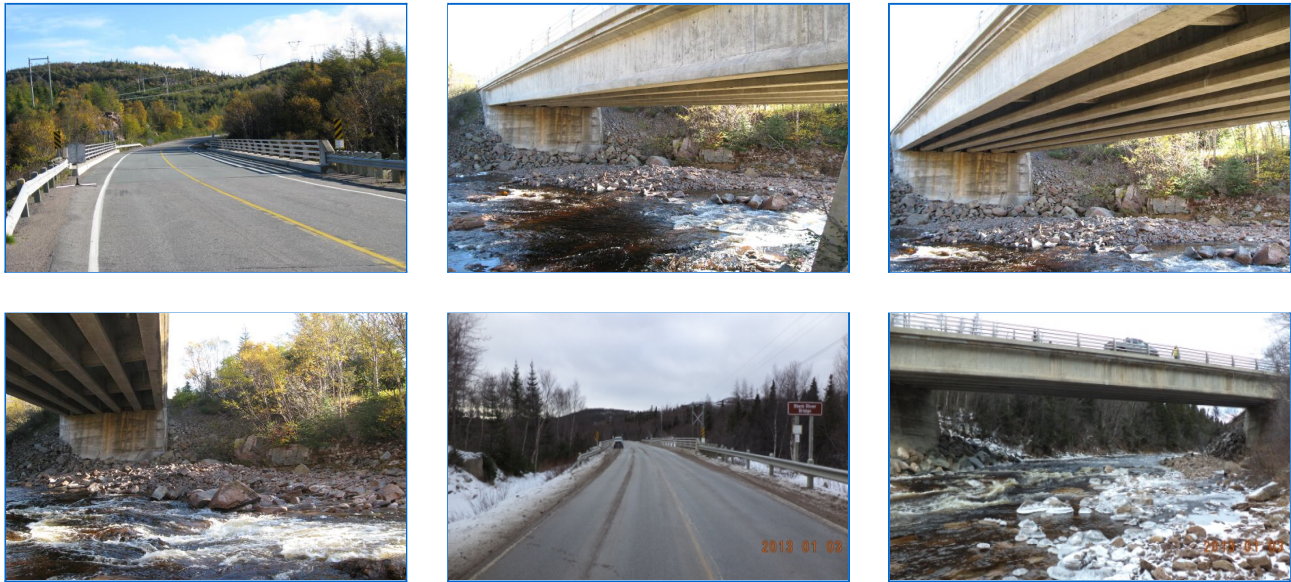
<b>SUBSTRUCTURE</b>			
<b>Condition:</b>	F2 - Fair	<b>Bearings:</b>	F2 - Fair
		<b>Bearing Seat:</b>	F2 - Fair
<b>Comments:</b>	Concrete abutments and wingwalls. A few cracks with efflorescence. Debris and formwork on bearing seat. Abutment 2 showing fill loss under wing wall.
