GOVERNMENT OF NEWFOUNDLAND AND LABRADOR Department of Transportation and Infrastructure	BRIDGE INSPECTION REPORT B10132021-8	
Date: 10/6/2021	Inspected By: Mike Button	Category: Office - Bridge Office	
BRIDGE INFORMATION			
Site:	2-163 - CHAPEL ARM BRIDGE NO.2		
Route:	201-10	Overall Length:	6.7 m
Year Built:	1960	Overall Width:	9.5 m
Year Last Rehab.:		Est: No	
Region:	CENTRAL EAST	Roadway Width:	6 m
Jurisdiction:	Provincial	Sidewalk Width:	0 m
Type of Structure:	03 - Reinforced Concrete Beam/Slab	Clearance to R.D. or N.W.L.:	1.5 m
Purpose of Structure:	04 - Over Non-Navigable Waters	Max Depth of N.W.L.:	0.5 m
Type of Handrail:	02 - Concrete Rail	Spans:	
Roadway Surface:	02 - Asphalt	<u>Span No.:</u>	<u>Length</u>
Alignment Vertical:	01 - Good	1	3.8
Alignment Horizontal:	02 - Adequate	2	0
Restrictions:	No	3	0
		<u>Span No.:</u>	<u>Length</u>
		4	0
		5	0
		6	0
BRIDGE PHOTOS

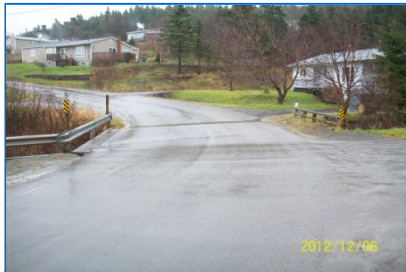
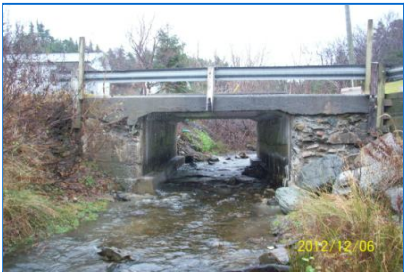
Bearing Seat:	I - Inapplicable
Comments:	- North frame leg exterior faces have severe disintegration, large (>300mm aggregated exposed). Northeast corner has severe disintegration and a void extending back to sloped earth fill materials, P3. - South frame leg exterior faces in fair condition. Half the southwest wingwall (no rebar) has cracked off and is in the river below. Surrounding soils left unprotected, P3. - East frame leg face (under structure) has medium cracking throughout. Northeast section of frame leg as severe effloresce leaking from the slab/top of wall joint and building up on the face, P1. - West frame leg face (under structure) has medium horizontal cracking across the bottom 1m with medium efflorescence. Northwest section has severe effloresce leaking from the slab/top of wall joint and building up on the face, P1.		
SUPERSTRUCTURE			
Condition:	P3 - Poor	Expansion Joints:	I - Inapplicable

- Both fascia's in fair condition. - Bottom of deck is heavily cracked with severe efflorescence on the north half of

Comments: the structure (P3), map cracking covers the south half (P3). Bottom of deck on the north side also has a medium sized spall to extremely corroded reinforcing steel, P3.

Condition:	P3 - Poor	Curbs:	I - Inapplicable
Hand Rail:	P3 - Poor	Roadway Condition:	F1 - Fair
Approach Rail:	I - Inapplicable		
Comments:	- Asphalt in fair condition. - No approach/exit rail due to surrounding properties/homes. Hazard markers mostly missing. No end blocks. - South handrail in poor condition and too low, P3. South roadway edge to south handrail grown over with grass. - North structure guiderail in fair condition, some posts are getting old/worn, F1. - Deck concrete cracked and leaking below, P3.

Next Rehab. Date:		Replacement Year:	2024
Antic. Rehab. Cost:	\$	Replacement Cost:	\$500,000
Recommendations:	- Recommend replacing structure with a culvert within 3 years.
