GOVERNMENT OF NEWFOUNDLAND AND LABRADOR Department of Transportation and Infrastructure	BRIDGE INSPECTION REPORT B10132021-6	
Date: 10/6/2021	Inspected By: Mike Button	Category: Office - Bridge Office	
BRIDGE INFORMATION			
Site:	2-143 - CHAPEL ARM BRIDGE NO.3		
Route:	201	Overall Length:	4 m
Year Built:	1960	Est: No	Overall Width: 8.2 m
Year Last Rehab.:		Est: No	Roadway Width: 7.9 m
Region:	CENTRAL EAST	Sidewalk Width:	0 m
Jurisdiction:	Provincial	Clearance to R.D. or N.W.L.:	2 m
Type of Structure:	03 - Reinforced Concrete Beam/Slab	Max Depth of N.W.L.:	1 m
Purpose of Structure:	04 - Over Non-Navigable Waters	Spans:	
Type of Handrail:	06 - None	<u>Span No.:</u>	<u>Length</u>
Roadway Surface:	02 - Asphalt	1	3
Alignment Vertical:	01 - Good	2	0
Alignment Horizontal:	01 - Good	3	0
Restrictions:	No	4	0
		5	0
		6	0
BRIDGE PHOTOS

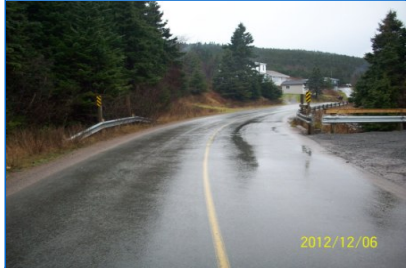
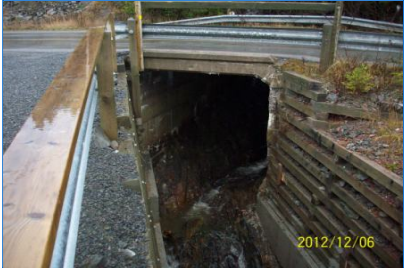
Comments:	- East frame legs have medium disintegration caused from runoff. Water path also eroding fill from the concrete face/timber retaining wall joint, P3. - West frame legs have medium cracking and rust staining throughout. - South frame leg face has medium cracking with mild efflorescence throughout. Construction joint about 1m off bedrock on the west half of the structure has a medium-large spall. Southeast corner of the frame has a wide crack on an approximate 45 degree angle to the west, P1. - North frame leg face has mild scour near the midpoint of the structure, and medium cracking with efflorescence throughout. - Both downstream (east) concrete retaining structure footings have medium scour. Timber retaining structures in fair condition. - No retaining structures upstream.		
SUPERSTRUCTURE			
Condition:	P3 - Poor	Expansion Joints:	I - Inapplicable

- East fascia has medium-severe disintegration at the roadway level due to runoff and medium horizontal cracking

Comments: throughout the face. - West fascia has severe disintegration throughout. Frame leg to fascia transition has medium 45 degree cracks, P3. - Frame leg transition to bottom of deck (under structure) has medium-severe cracking with efflorescence throughout, P3, especially at structure exteriors, P1. Heavy leakage seen running down both frame leg faces, P3. - Bottom of deck has medium longitudinal cracks with efflorescence throughout.

Condition:	P3 - Poor	Curbs:	I - Inapplicable
Hand Rail:	F2 - Fair	Roadway Condition:	F2 - Fair
Approach Rail:	F2 - Fair		
Comments:	- Asphalt in fair condition. - Approach/exit rail in good condition, properties around structure impact its effectiveness. - No hazard markers, end blocks or curbs. - Deck cracked and leaking, indicated by efflorescence on bottom of deck, P3.

Water Velocity:	1 m/s	Ice Problem:	N - No Problem
Water Depth:	0.2 m	Scour Problem:	K - Known Problem
Waterway:	01 - Adequate	Debris Problem:	N - No Problem
Comments:	- Mild scour issues under frame legs and retaining structure footings. Bedrock grade steep through structure.

Next Rehab. Date:		Replacement Year:	2024
Antic. Rehab. Cost:	\$REPLACE	Replacement Cost:	\$1,000,000
Recommendations:	- Replace structure. Replacement has to be cast in place due to bedrock geometry below.

Overall Condition:	P3 - Poor	Requires Further Inspection:	No
Additional Observations:	- Replace within 3 years. - Hazards, mild traffic, structure on a horizontal curve, steep slopes and slippery bedrock travelling under the structure.
