**BRIDGE INSPECTION REPORT  
B06012020-1**

Site:	2-169 - CLAM BROOK BRIDGE (OLD)		
Route:	210	Overall Length:	14 m
Year Built:	1950	Overall Width:	7 m
Year Last Rehab.:		Est: Yes	
Region:	CENTRAL EAST	Est: No	
Jurisdiction:	Provincial	Roadway Width:	6.5 m
Type of Structure:	03 - Reinforced Concrete Beam/Slab	Sidewalk Width:	0 m
Purpose of Structure:	04 - Over Non-Navigable Waters	Clearance to R.D. or N.W.L.:	3 m
Type of Handrail:	02 - Concrete Rail	Max Depth of N.W.L.:	2 m
Roadway Surface:	01 - Concrete	<b>Spans:</b>	
Alignment Vertical:	01 - Good	<u>Span No.:</u>	<u>Length</u>
Alignment Horizontal:	01 - Good	<u>Span No.:</u>	<u>Length</u>
Restrictions:	No	1	8
		2	0
		3	0
		4	0
		5	0
		6	0

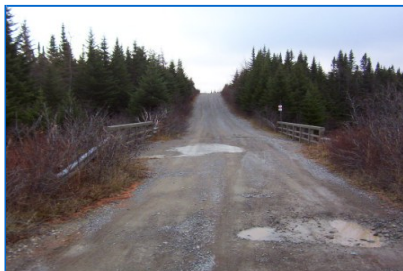
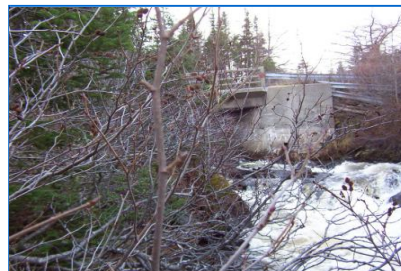
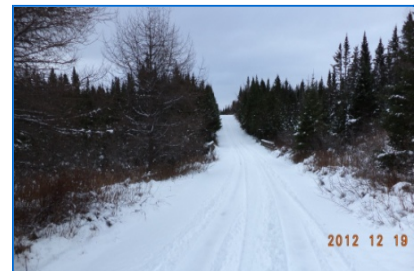
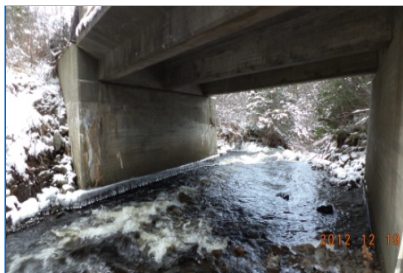
Comments: Concrete abutments and wingwalls. Some significant vertical cracks in the abutment wall, especially abutment one left and abutment two right where the wingwalls are tipping out and cracking away from the structure.

Cracking with efflorescence all wingwalls. Some rusting of the steel bearing plates.

**Condition:** P3 - Poor **Expansion Joints:** I - Inapplicable  
**Comments:** 3 reinforced concrete beams, cracking and weathering.

**Condition:** P3 - Poor **Curbs:** I - Inapplicable  
**Hand Rail:** P3 - Poor **Roadway Condition:** I - Inapplicable  
**Approach Rail:** P1 - Poor  
**Comments:** Exposed concrete deck, gravel approaches. Some gravel debris on deck, some cracking. Concrete hand rail, one section replaced with flex beam, poor condition. Approach rail is leaned, grown in with alders and posts are rotted. Retaining structure abutment one left side has failed and the corner is washed out. Deck appears to be potholed.

**Water Velocity:** 1.5 m/s **Ice Problem:** N - No Problem  
**Water Depth:** 1.0 m **Scour Problem:** P - Possible Problem  
**Waterway:** 01 - Adequate **Debris Problem:** N - No Problem  
**Comments:** Abutment 1 has horizontal and diagonal cracks appearing through it; flow is concentrated on abutment 1 footings and should be checked for scour.

**Next Rehab. Date:** 2020 **Replacement Year:** 2020  
**Antic. Rehab. Cost:** \$0 **Replacement Cost:** \$0  
**Recommendations:** Replace with culvert when feasible.
