GOVERNMENT OF NEWFOUNDLAND AND LABRADOR Department of Transportation and Infrastructure	BRIDGE INSPECTION REPORT B06112021-1	
Date: 6/11/2021	Inspected By: Alex Ford	Category: Eng. - Engineering	
BRIDGE INFORMATION			
Site:	2-121 - CULL'S HARBOUR BAILEY BRIDGE		
Route:	310-13	Overall Length:	102 m
Year Built:	1990	Est: No	Overall Width: 5 m
Year Last Rehab.:	2007	Est: No	Roadway Width: 3.3 m
Region:	CENTRAL EAST	Sidewalk Width:	0 m
Jurisdiction:	Provincial	Clearance to R.D. or N.W.L.:	4.5 m
Type of Structure:	09 - Bailey Bridge	Max Depth of N.W.L.:	4 m
Purpose of Structure:	03 - Over Navigable Waters	Spans:	
Type of Handrail:	06 - None	Span No.:	Length
Roadway Surface:	03 - Timber	1	50.3
Alignment Vertical:	01 - Good	2	50.3
Alignment Horizontal:	01 - Good	3	0
Restrictions:	Yes	4	0
Describe Restrictions:	Loads restricted to 5t starting 31 May 2021 until further notice.		
BRIDGE PHOTOS

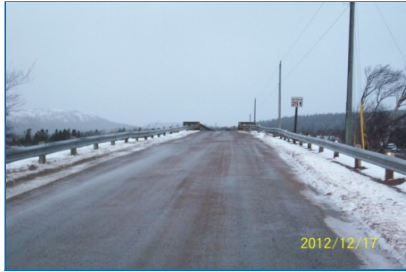
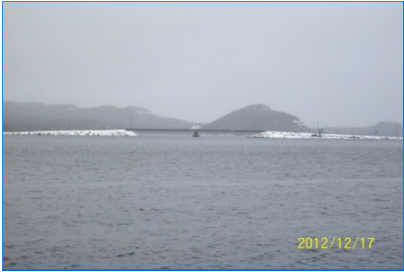
Condition:	F2 - Fair	Bearings:	F2 - Fair
		Bearing Seat:	F2 - Fair
Comments:	Concrete abutments each end - some cracking. Steel centre pier surface rusting all components above water with areas of scaling and flaking, especially in the tidal zone; below water uninspectable. Sliding bearing for panel bridge abutment one some deterioration of the grout pads, sliding bearings @ centre pier good condition, fixed bearing for panel bridge abutment two some deterioration of the grout pad.		
SUPERSTRUCTURE			
Condition:	P - Poor	Expansion Joints:	I - Inapplicable
Comments:	Significant rusting of the stringer sets throughout bridge - some sets have failed. 85 out of 132 sets should be replaced. Upper sway brace in every bay is severely rusted and requires replacement. Vertical bracing bolts severely rusted and requires replacement. Transoms and panels in fair to good condition.		
DECK

Condition:	F2 - Fair	Curbs:	F2 - Fair
Hand Rail:	F2 - Fair	Roadway Condition:	F2 - Fair
Approach Rail:	P3 - Poor		
Comments:	Deck chesses mostly fair condition, some need replacement due to weakened stringers. Raceway in poor shape, constant maintenance issue, requires replacement. Guide rail at all corners poor condition.

Next Rehab. Date:	2021	Replacement Year:	2021
Antic. Rehab. Cost:	\$200000	Replacement Cost:	\$0
Recommendations:	Reduce loading until repairs are made. Tender 47-21PSE to address issues.
