GOVERNMENT OF NEWFOUNDLAND AND LABRADOR Department of Transportation and Infrastructure	BRIDGE INSPECTION REPORT B09112020-2	
Date: 9/8/2020	Inspected By: AB	Category: Eng. - Engineering	
BRIDGE INFORMATION			
Site:	TCH-014 - DEEP BIGHT RIVER BRIDGE		
Route:	1	Overall Length:	25 m
Year Built:	1994	Est: No	Overall Width: 45 m
Year Last Rehab.:		Est: No	Roadway Width: 16 m
Region:	CENTRAL EAST	Sidewalk Width:	0 m
Jurisdiction:	Provincial	Clearance to R.D. or N.W.L.:	10 m
Type of Structure:	04 - Rigid Frame	Max Depth of N.W.L.:	1.5 m
Purpose of Structure:	04 - Over Non-Navigable Waters		
Type of Handrail:	06 - None	Spans:	
Roadway Surface:	02 - Asphalt	<u>Span No.:</u>	<u>Length</u>
Alignment Vertical:	01 - Good	1	8.5
Alignment Horizontal:	01 - Good	2	0
Restrictions:	No	3	0
		<u>Span No.:</u>	<u>Length</u>
		4	0
		5	0
		6	0
BRIDGE PHOTOS

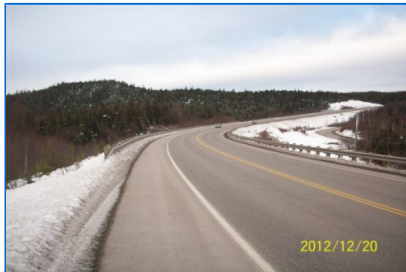
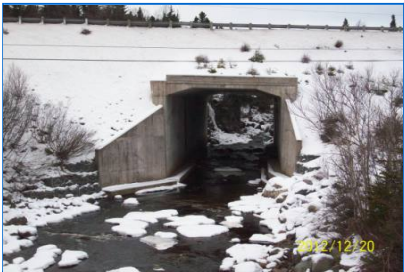
Bearing Seat:	I - Inapplicable
Comments:	Concrete footings, abutments and wing walls. Erosion and scaling of footings. Some light cracking in abutments and wing walls. Water and efflorescence due to leaking vertical construction joints - with active wet areas and some spalling. Two joints per abutment wall. Gabion retaining structures abutment one and two right side. Gabions on Downstream right side are broken and losing fill. Downstream left are bulging.		
SUPERSTRUCTURE			
Condition:	F2 - Fair	Expansion Joints:	I - Inapplicable
Comments:	Light cracking of soffit. Water and efflorescence due to leaking construction joints - with active wet areas and some spalling. Two joints.		
DECK

Water Velocity:	1.5 m/s	Ice Problem:	N - No Problem
Water Depth:	1 m	Scour Problem:	K - Known Problem
Waterway:	01 - Adequate	Debris Problem:	N - No Problem
Comments:	Abutment 2 downstream footing is scoured at least 400mm under footing and 50-150mm deep.

Next Rehab. Date:		Replacement Year:	
Antic. Rehab. Cost:	\$50000	Replacement Cost:	\$0
Recommendations:	Seal Construction Joints, replace Gabions and repair scour
