GOVERNMENT OF NEWFOUNDLAND AND LABRADOR Department of Transportation and Infrastructure	BRIDGE INSPECTION REPORT B05292020-21	
Date: 5/27/2020	Inspected By: AB	Category: Eng. - Engineering	
BRIDGE INFORMATION			
Site:	2-098 - FAIRHAVEN BRIDGE NORTH		
Route:	203-10	Overall Length:	13.7 m
Year Built:	1970	Est: No	Overall Width: 7.8 m
Year Last Rehab.:		Est: No	Roadway Width: 7 m
Region:	CENTRAL EAST	Sidewalk Width:	0 m
Jurisdiction:	Provincial	Clearance to R.D. or N.W.L.:	2.2 m
Type of Structure:	11 - Timber Bridge	Max Depth of N.W.L.:	0.5 m
Purpose of Structure:	04 - Over Non-Navigable Waters		
Type of Handrail:	06 - None	Spans:	
Roadway Surface:	03 - Timber	<u>Span No.:</u>	<u>Length</u>
Alignment Vertical:	01 - Good	1	6.2
Alignment Horizontal:	01 - Good	2	0
Restrictions:	No	3	0
		<u>Span No.:</u>	<u>Length</u>
		4	0
		5	0
		6	0
BRIDGE PHOTOS

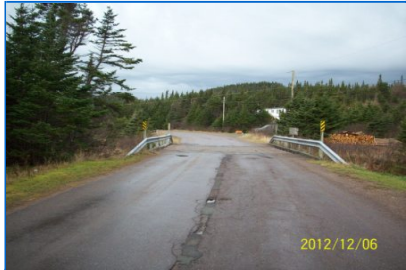
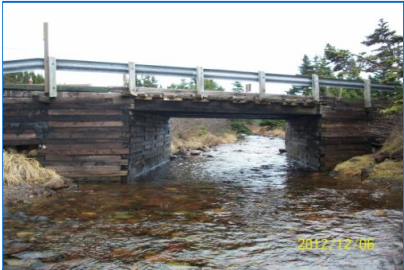
Bearing Seat:	F2 - Fair
Comments:	Creosote timber abutments and wing walls. Some minor cracking and decay with gaps in the bottom allowing fill through abutment two and abutment two wingwall. Abutment 2 appears to have minor scouring. Abutment 2/wingwall 2 left side appears to be settling due to fill loss.		
SUPERSTRUCTURE			
Condition:	F2 - Fair	Expansion Joints:	I - Inapplicable
Comments:	Nine creosote timber beams 10" x 14", fair to good condition.		
DECK			
Condition:	F2 - Fair	Curbs:	F2 - Fair

Hand Rail:	F2 - Fair	Roadway Condition:	F2 - Fair
Approach Rail:	I - Inapplicable		
Comments:	Galvanized flex beam hand rail. 75mm timber decking with 50mm wearing surface. Some deterioration areas on wearing surface. Settlement evident over approach two, left possibly related to gaps in abutment and wingwall. Approach 1 has many potholes.		
HYDROLOGY			
Water Velocity:	1 m/s	Ice Problem:	N - No Problem
Water Depth:	0.5 m	Scour Problem:	P - Possible Problem
Waterway:	01 - Adequate	Debris Problem:	N - No Problem
Comments:	Some loss of fill at abutment two which may lead to scour.		
REPLACEMENT/REHABILITATION			
Next Rehab. Date:		Replacement Year:	
Antic. Rehab. Cost:	\$0	Replacement Cost:	\$0
Recommendations:	Place hydraulic rip rap at corners and along crib abutments of scour protection.		
OBSERVATIONS			
Overall Condition:	F2 - Fair	Requires Further Inspection:	No
Additional Observations:			
LEGEND:
