GOVERNMENT OF NEWFOUNDLAND AND LABRADOR Department of Transportation and Infrastructure	BRIDGE INSPECTION REPORT B05292020-22	
Date: 5/27/2020	Inspected By: AB	Category: Eng. - Engineering	
BRIDGE INFORMATION			
Site:	2-099 - FAIRHAVEN BRIDGE SOUTH		
Route:	203	Overall Length:	15 m
Year Built:	1970	Est: No	Overall Width: 7.4 m
Year Last Rehab.:	2013	Est: No	Roadway Width: 6.4 m
Region:	CENTRAL EAST	Sidewalk Width:	0 m
Jurisdiction:	Provincial	Clearance to R.D. or N.W.L.:	1.6 m
Type of Structure:	08 - Steel Bridge	Max Depth of N.W.L.:	1 m
Purpose of Structure:	04 - Over Non-Navigable Waters		
Type of Handrail:	04 - Steel Rail	Spans:	
Roadway Surface:	03 - Timber	<u>Span No.:</u>	<u>Length</u>
Alignment Vertical:	01 - Good	1	9.7
Alignment Horizontal:	01 - Good	2	0
Restrictions:	No	3	0
		<u>Span No.:</u>	<u>Length</u>
		4	0
		5	0
		6	0
BRIDGE PHOTOS

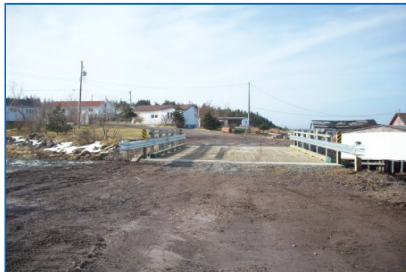
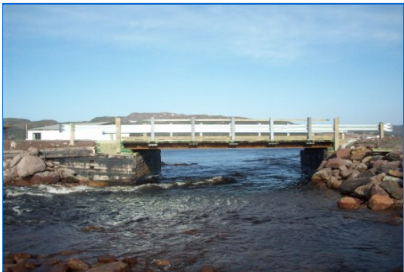
Bearing Seat:	F2 - Fair
Comments:	Cresote timber abutments and timber walls. Some medium cracking and decay throughout. Scour repairs made 2013 with concrete. Timber repairs on wing walls made 2013. Abutment 2 wing walls appear to be bulging along with Abutment 1 right side.		
SUPERSTRUCTURE			
Condition:	F2 - Fair	Expansion Joints:	I - Inapplicable
Comments:	Eight new steel beams with bracing installed 2013. Some light surface rusting.		
DECK			
Condition:	F2 - Fair	Curbs:	F2 - Fair

Hand Rail:	F2 - Fair	Roadway Condition:	F2 - Fair
Approach Rail:	F2 - Fair		
Comments:	100mm x 200mm rough treated timber decking with 50mm x 150mm rough treated timber raceway. 150mm x 150mm rough treated timber curbs. Bridge rail is galvanized steel posts mounted to timber deck with galvanized flex beam and 100mm x 100mm dressed hand rail. Hand rail left side is broken. Object marker is missing abutment two right side.

Next Rehab. Date:		Replacement Year:	
Antic. Rehab. Cost:	\$0	Replacement Cost:	\$0
Recommendations:	Repair hand rail, replace missing object marker.
