GOVERNMENT OF NEWFOUNDLAND AND LABRADOR Department of Transportation and Infrastructure	BRIDGE INSPECTION REPORT B04282021-6	
Date: 4/20/2021	Inspected By: Butler	Category: Eng. - Engineering	
BRIDGE INFORMATION			
Site:	TCH-028 - GAMBO RIVER BRIDGE		
Route:	1	Overall Length:	80 m
Year Built:	1960	Est: Yes	Overall Width: 11.8 m
Year Last Rehab.:	2019	Est: No	Roadway Width: 10.5 m
Region:	CENTRAL EAST	Sidewalk Width:	0 m
Jurisdiction:	Provincial	Clearance to R.D. or N.W.L.:	3 m
Type of Structure:	01 - AASH to Girder	Max Depth of N.W.L.:	1 m
Purpose of Structure:	03 - Over Navigable Waters	Spans:	
Type of Handrail:	01 - Aluminum Rail	<u>Span No.:</u>	<u>Length</u>
Roadway Surface:	01 - Concrete	1	23.5
Alignment Vertical:	01 - Good	2	23.5
Alignment Horizontal:	01 - Good	3	23.5
Restrictions:	No	<u>Span No.:</u>	<u>Length</u>
		4	0
		5	0
		6	0
BRIDGE PHOTOS

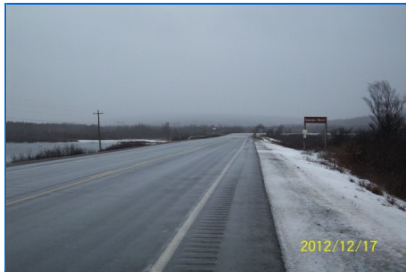
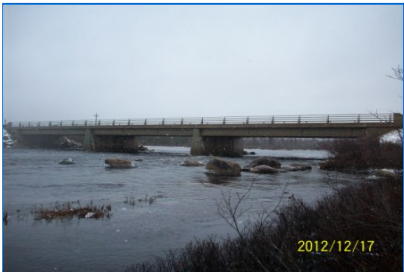
Bearing Seat:	F2 - Fair
Comments:	Expansion Joints may be leaking		
SUPERSTRUCTURE			
Condition:	F2 - Fair	Expansion Joints:	F2 - Fair
Comments:	Joint 3 and 4 have cracking in deck around joint with extreme cracking and lose of concrete around abutment 2 joint.		
DECK			
Condition:	F2 - Fair	Curbs:	F2 - Fair
Hand Rail:	F2 - Fair	Roadway Condition:	F2 - Fair

Approach Rail:	F2 - Fair		
Comments:	Exposed concrete deck. Aluminum 4 rail system with concrete end blocks. Dymeric sealant is cracking.		
HYDROLOGY			
Water Velocity:	1 m/s	Ice Problem:	N - No Problem
Water Depth:	1.5 m	Scour Problem:	P - Possible Problem
Waterway:	01 - Adequate	Debris Problem:	N - No Problem
Comments:	Couldn't check centre piers for scour. No known issues.		
REPLACEMENT/REHABILITATION			
Next Rehab. Date:		Replacement Year:	
Antic. Rehab. Cost:	\$0	Replacement Cost:	\$0
Recommendations:	Repair deck and joints		
OBSERVATIONS			
Overall Condition:	F2 - Fair	Requires Further Inspection:	No
Additional Observations:			
LEGEND:			
Condition Definitions:			
1 - *Good - [discontinued code].	F2 - Fair.	C - Unsafe (Closed to Public).	Problem Definitions:
2 - *Fair - [discontinued code].	F1 - Fair.	U - Uninspectable.	N - No Problem.
3 - *Poor - [discontinued code].	P3 - Poor.	I - Inapplicable.	P - Possible Problem.
