GOVERNMENT OF NEWFOUNDLAND AND LABRADOR Department of Transportation and Infrastructure	BRIDGE INSPECTION REPORT B09012023-8	
Date: 8/21/2023	Inspected By: Darrell Avery	Category: Eng. - Engineering	
BRIDGE INFORMATION			
Site:	2-128 - GEORGE'S BROOK BRIDGE #2		
Route:	230A	Overall Length:	25 m
Year Built:	2007	Est: No	Overall Width: 11 m
Year Last Rehab.:	2019	Est: No	Roadway Width: 8.3 m
Region:	CENTRAL EAST	Sidewalk Width:	1.2 m
Jurisdiction:	Provincial	Clearance to R.D. or N.W.L.:	2 m
Type of Structure:	03 - Reinforced Concrete Beam/Slab	Max Depth of N.W.L.:	1 m
Purpose of Structure:	04 - Over Non-Navigable Waters	Spans:	
Type of Handrail:	01 - Aluminum Rail	Span No.:	Length
Roadway Surface:	02 - Asphalt	1	13.5
Alignment Vertical:	01 - Good	2	0
Alignment Horizontal:	01 - Good	3	0
Restrictions:	No	4	0
		5	0
		6	0
BRIDGE PHOTOS

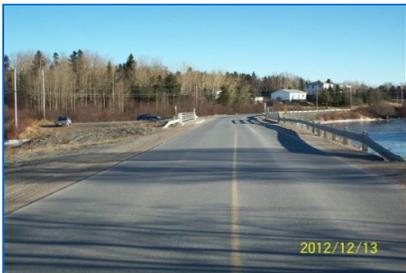
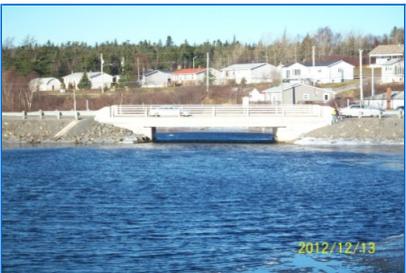
Hand Rail:		Roadway Condition:	
Approach Rail:	F2 - Fair		
Comments:	Aluminum bridge rail with concrete end blocks. Asphalt wearing surface. Extensive potholing and exposed waterproofing in left lane. Deck covered in sand. New inspection - Asphalt continuing to rut, ravel and pothole. Wood blocks in curb fascia - some popping out.		
HYDROLOGY			
Water Velocity:	0.5 m/s	Ice Problem:	N - No Problem
Water Depth:	1.0-1.50 m	Scour Problem:	N - No Problem
Waterway:	01 - Adequate	Debris Problem:	N - No Problem
Comments:	Tidal		
REPLACEMENT/REHABILITATION			
Next Rehab. Date:		Replacement Year:	
Antic. Rehab. Cost:	\$0	Replacement Cost:	\$0
Recommendations:	Approach 2 right required gutter at wingwall. Clean sand from gutter		
OBSERVATIONS			
Overall Condition:	F2 - Fair	Requires Further Inspection:	No
Additional Observations:	Approach 2 right has washout near wingwall. Municipal water supply suspended from left curb fascia.
