GOVERNMENT OF
NEWFOUNDLAND
AND LABRADOR
Department of Transportation and Infrastructure

**BRIDGE INSPECTION REPORT
B08022021-1**

Date: 5/6/2021

Site:	2-171 - GOOBIES BRIDGE (OLD)			Overall Length:	25 m
Route:	210			Overall Width:	7 m
Year Built:	2011	Est: No		Roadway Width:	4.1 m
Year Last Rehab.:		Est: No		Sidewalk Width:	0 m
Region:	CENTRAL EAST			Clearance to R.D. or N.W.L.:	2 m
Jurisdiction:	Provincial			Max Depth of N.W.L.:	1 m
Type of Structure:	09 - Bailey Bridge			Spans:	
Purpose of Structure:	03 - Over Navigable Waters				
Type of Handrail:	06 - None			<u>Span No.:</u>	<u>Length</u>
Roadway Surface:	03 - Timber			1	24.4
Alignment Vertical:	01 - Good			2	0
Alignment Horizontal:	01 - Good			3	0
Restrictions:	Yes			<u>Span No.:</u>	<u>Length</u>
Describe Restrictions:	Bridge is one lane only. Mabey Compact 200 SSHR++ Extra Wide, 8 panels long.

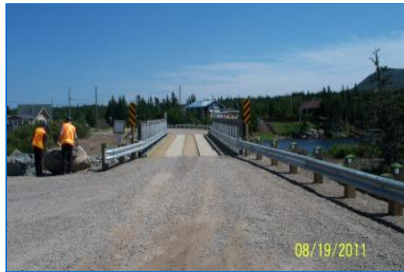
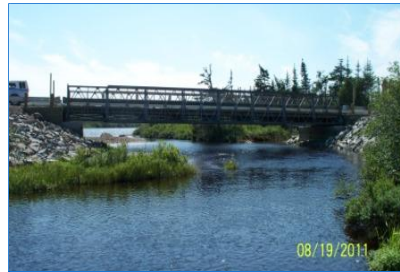
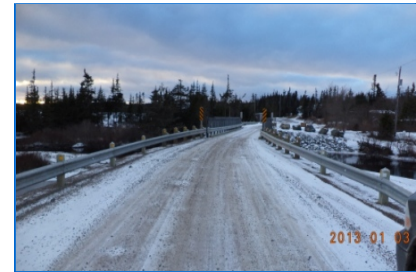
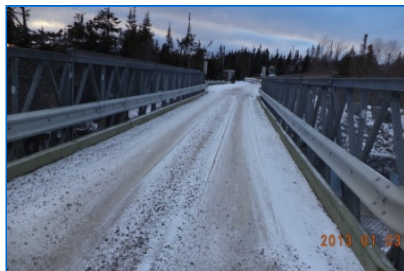
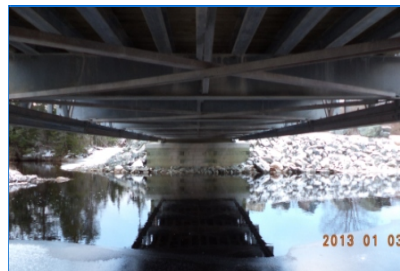
Comments: Pressure treated timber crib abutments with concrete bearing seats. Some debris on bearing seat. Rusting

starting on Girders.

Comments: 75mm timber deck with 50mm timber wearing surface. Timber chesses are too closely spaced, allowing gravel and sand to remain on the deck collecting moisture. Raceway timbers worn. Some light impact damage on approach rail and right side wheel guard over abutment 1. impact damage to chain link fencing and bridge rail over abutment 1 left side. Approach 2 left buried end is broken.

Recommendations: When timbers require replacement in several years time, space them out 30-50mm between them. Replace buried end Clean deck Repair wheel guard and fencing
