GOVERNMENT OF NEWFOUNDLAND AND LABRADOR Department of Transportation and Infrastructure	<b>BRIDGE INSPECTION REPORT</b> <b>B08152024-3</b>	
<b>Date:</b> 8/15/2024	<b>Inspected By:</b> L. Christensen/D.Burns	<b>Category:</b> Office - Bridge Office	
<b>BRIDGE INFORMATION</b>			
<b>Site:</b>	2-030 - GRAND BANK BROOK BRIDGE (NO.1)		
<b>Route:</b>	210	<b>Overall Length:</b>	31.8 m
<b>Year Built:</b>	1968	<b>Est:</b> No	<b>Overall Width:</b> 11.5 m
<b>Year Last Rehab.:</b>		<b>Est:</b> No	<b>Roadway Width:</b> 8.5 m
<b>Region:</b>	CENTRAL EAST		<b>Sidewalk Width:</b> 1.1 m
<b>Jurisdiction:</b>	Provincial		<b>Clearance to R.D. or N.W.L.:</b> 3.3 m
<b>Type of Structure:</b>	01 - AASH to Girder		<b>Max Depth of N.W.L.:</b> 1 m
<b>Purpose of Structure:</b>	04 - Over Non-Navigable Waters		<b>Spans:</b>
<b>Type of Handrail:</b>	02 - Concrete Rail		
<b>Roadway Surface:</b>	02 - Asphalt	<b>Span No.:</b>	<b>Length</b>

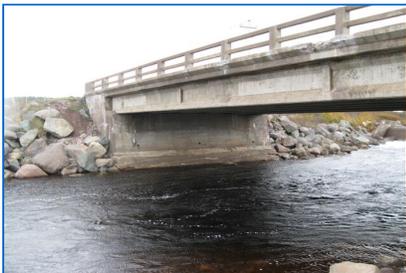
<b>SUBSTRUCTURE</b>			
<b>Condition:</b>	P3 - Poor	<b>Bearings:</b>	U - Uninspectable
		<b>Bearing Seat:</b>	U - Uninspectable
<b>Comments:</b>	Medium cracks, concrete deterioration and efflorescence on wing walls and abutments. Medium erosion on southern abutment. Evidence of expansion joints leaking onto abutments.		
<b>SUPERSTRUCTURE</b>			
<b>Condition:</b>	F1 - Fair	<b>Expansion Joints:</b>	U - Uninspectable
<b>Comments:</b>	Expansion joints paved over. Low cover spalling exposing bottom reinforcement on east girder (outside) at midpoint.		
<b>DECK</b>			
<b>Condition:</b>	F1 - Fair	<b>Curbs:</b>	P1 - Poor

<b>Hand Rail:</b>	P3 - Poor	<b>Roadway Condition:</b>	F1 - Fair
<b>Approach Rail:</b>	F1 - Fair		
<b>Comments:</b>	Water staining and minor efflorescence around deck drain holes (no pipes). Curbs have severe concrete deterioration on fascia (rebar showing) and sidewalks. Hand rail is old concrete rail with medium cracks.		
<b>HYDROLOGY</b>			
<b>Water Velocity:</b>	0 m/s	<b>Ice Problem:</b>	N - No Problem
<b>Water Depth:</b>	0 m	<b>Scour Problem:</b>	N - No Problem
<b>Waterway:</b>	01 - Adequate	<b>Debris Problem:</b>	N - No Problem
<b>Comments:</b>	Old spillway directly upstream.		
<b>REPLACEMENT/REHABILITATION</b>			
<b>Next Rehab. Date:</b>	2030	<b>Replacement Year:</b>	
<b>Antic. Rehab. Cost:</b>	\$0	<b>Replacement Cost:</b>	\$0
<b>Recommendations:</b>			
<b>OBSERVATIONS</b>			
<b>Overall Condition:</b>	F1 - Fair	<b>Requires Further Inspection:</b>	No
<b>Additional Observations:</b>	Monitor girder deterioration and curb/sidewalk/hand rail for safety concerns.
