GOVERNMENT OF NEWFOUNDLAND AND LABRADOR Department of Transportation and Infrastructure	BRIDGE INSPECTION REPORT B10202017-3	
Date: 10/13/2017	Inspected By: AB	Category: Eng. - Engineering	
BRIDGE INFORMATION			
Site:	2-206 - HODDERVILLE BRIDGE (BLACKHEAD BAY) (OLD)		
Route:	235	Overall Length:	16 m
Year Built:	1940	Est: Yes	Overall Width: 5.5 m
Year Last Rehab.:		Est: No	Roadway Width: 5 m
Region:	CENTRAL EAST	Sidewalk Width:	0 m
Jurisdiction:	Provincial	Clearance to R.D. or N.W.L.:	2 m
Type of Structure:	03 - Reinforced Concrete Beam/Slab	Max Depth of N.W.L.:	1 m
Purpose of Structure:	04 - Over Non-Navigable Waters	Spans:	
Type of Handrail:	02 - Concrete Rail	<u>Span No.:</u>	<u>Length</u>
Roadway Surface:	01 - Concrete	1	9
Alignment Vertical:	01 - Good	2	0
Alignment Horizontal:	01 - Good	3	0
Restrictions:	No	<u>Span No.:</u>	<u>Length</u>
		4	0
		5	0
		6	0
BRIDGE PHOTOS

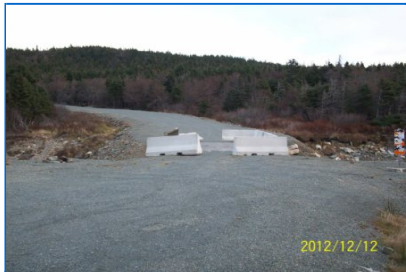
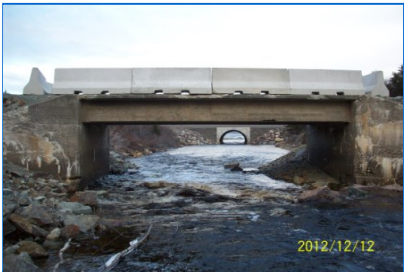
Bearing Seat:	I - Inapplicable
Comments:	Concrete abutments and wing walls. Wing walls right side have disintegration, scaling and cracking with efflorescence. Some areas of disintegration on abutments, remainder has erosion, cracking and efflorescence. Severe vertical cracks at all four wing walls where they meet the abutments - wing walls unstable.		
SUPERSTRUCTURE			
Condition:	C - Unsafe (Closed to Public)	Expansion Joints:	I - Inapplicable
Comments:	Three concrete beams. Light cracking, no visible deflection. Beam three has an area of disintegration/delamination with exposed rebar.		
DECK			
Condition:	C - Unsafe (Closed to Public)	Curbs:	C - Unsafe (Closed to Public)

Hand Rail:	C - Unsafe (Closed to Public)	Roadway Condition:	C - Unsafe (Closed to Public)
Approach Rail:	I - Inapplicable		
Comments:	Exposed concrete deck. Severe scaling. Concrete bridge rail left side in poor condition, no bridge rail right side - jersey barriers placed on bridge deck for barrier right side. Abutment #2 left jersey barrier has fallen into the brook.		
HYDROLOGY			
Water Velocity:	1.0 m/s	Ice Problem:	N - No Problem
Water Depth:	0.5 m	Scour Problem:	P - Possible Problem
Waterway:	01 - Adequate	Debris Problem:	N - No Problem
Comments:	Minor scour at abutment two due to rock erosion.		
REPLACEMENT/REHABILITATION			
Next Rehab. Date:	2017	Replacement Year:	2017
Antic. Rehab. Cost:	\$0	Replacement Cost:	\$0
Recommendations:	Remove or completely re-habilitate structure. Replace abutment #2 left jersey barrier.		
OBSERVATIONS			
Overall Condition:	C - Unsafe (Closed to Public)	Requires Further Inspection:	No
