GOVERNMENT OF
NEWFOUNDLAND
AND LABRADOR
Department of Transportation and Infrastructure

**BRIDGE INSPECTION REPORT
B02092021-1**

Date: 2/9/2021

Site:	2-175 - L'ANSE AU LOUP NO.1 (OLD)		
Route:	210	Overall Length:	8 m
Year Built:	1940	Overall Width:	5.5 m
Year Last Rehab.:		Est: Yes	
		Est: No	
Region:	CENTRAL EAST	Roadway Width:	5 m
Jurisdiction:	Provincial	Sidewalk Width:	0 m
Type of Structure:	03 - Reinforced Concrete Beam/Slab	Clearance to R.D. or N.W.L.:	1 m
Purpose of Structure:	04 - Over Non-Navigable Waters	Max Depth of N.W.L.:	0.5 m
Type of Handrail:	06 - None	Spans:	
Roadway Surface:	01 - Concrete	<u>Span No.:</u>	<u>Length</u>
Alignment Vertical:	01 - Good	1	4
Alignment Horizontal:	01 - Good	2	0
Restrictions:	Yes	3	0
Describe Restrictions:	Closed to the public.

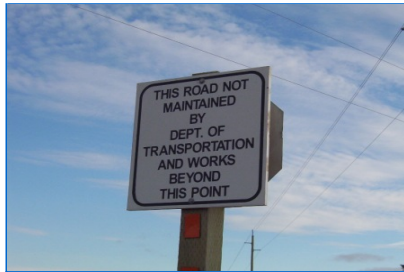
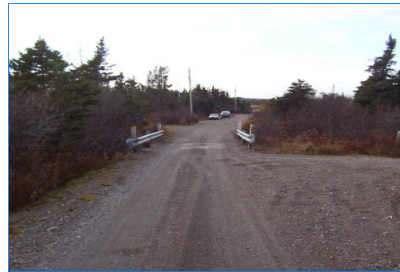
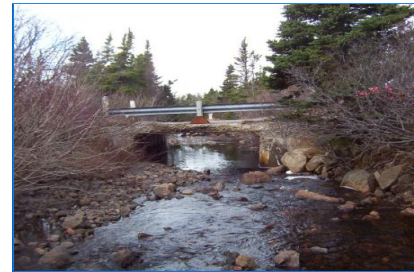
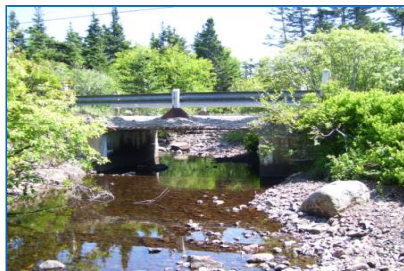
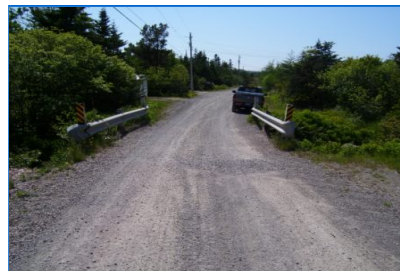
Comments: Concrete abutments and wingwalls. Extensive cracking, spalling, deterioration, delamination and efflorescence.

Abutment one wingwall left is broken and tilted out.

Condition: C - Unsafe (Closed to Public) **Expansion Joints:** I - Inapplicable
Comments: Concrete deck slab. Severe deterioration along edges with exposed rebar. Noticeable sag in superstructure - concrete has deteriorated to the point that there is little to no live load carrying capacity.

Condition: C - Unsafe (Closed to Public) **Curbs:** P1 - Poor
Hand Rail: P - Poor **Roadway Condition:** P1 - Poor
Approach Rail: I - Inapplicable
Comments: Exposed concrete deck with gravel approaches. Severe deterioration of deck edges. Handrail is flex beam attached to structure, anchorages loose, bolts pulled from concrete.

Water Velocity: 0.5 m/s **Ice Problem:** N - No Problem
Water Depth: 0.3 m **Scour Problem:** K - Known Problem
Waterway: 01 - Adequate **Debris Problem:** N - No Problem
Comments: Minor scour along abutment one left, not causing issues.

Next Rehab. Date: **Replacement Year:** 2021
Antic. Rehab. Cost: \$0 **Replacement Cost:** \$100000
Recommendations: Close bridge to public until replacement culverts can be installed.
