GOVERNMENT OF  
NEWFOUNDLAND  
AND LABRADOR  
Department of Transportation and Infrastructure

**BRIDGE INSPECTION REPORT**  
**B08052024-6**

Date: 8/2/2024

Site:	2-091 - LITTLE BAY BRIDGE			Overall Length:	40 m
Route:	220-10			Overall Width:	10.2 m
Year Built:	1988	Est: No		Roadway Width:	7.4 m
Year Last Rehab.:		Est: No		Sidewalk Width:	1.3 m
Region:	CENTRAL EAST			Clearance to R.D. or N.W.L.:	2 m
Jurisdiction:	Provincial			Max Depth of N.W.L.:	3 m
Type of Structure:	01 - AASH to Girder			<b>Spans:</b>	
Purpose of Structure:	03 - Over Navigable Waters			<u>Span No.:</u>	<u>Length</u>
Type of Handrail:	01 - Aluminum Rail			<u>Span No.:</u>	<u>Length</u>
Roadway Surface:	01 - Concrete			1	26.8
Alignment Vertical:	01 - Good			2	0
Alignment Horizontal:	01 - Good			3	0
Restrictions:	No			4	0
				5	0
				6	0

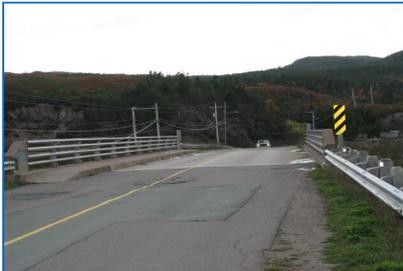
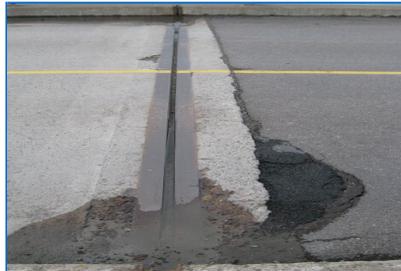
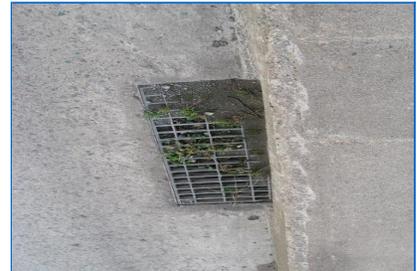
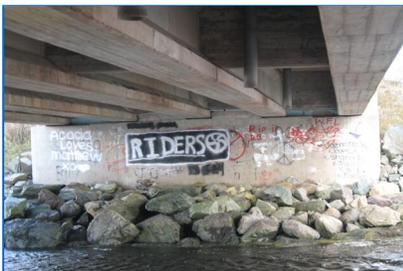
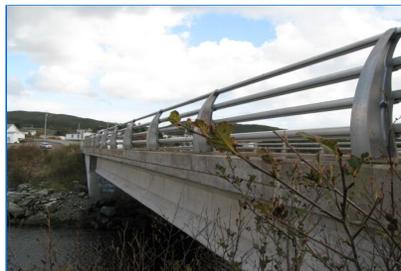
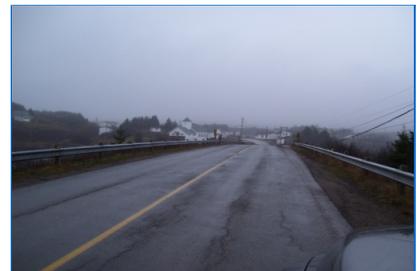
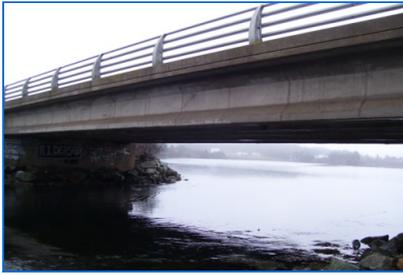
**BRIDGE PHOTOS**

<b>Condition:</b>	F2 - Fair	<b>Bearings:</b>	F1 - Fair
		<b>Bearing Seat:</b>	F2 - Fair
<b>Comments:</b>	All substructure in fair condition. Bearings are either squat or cracked in some areas.

<b>Condition:</b>	F2 - Fair	<b>Expansion Joints:</b>	P3 - Poor
<b>Comments:</b>	Superstructure in overall fair condition. Expansion joints in poor condition due to sand filling the seals, also suspected to be leaking.

<b>Condition:</b>	P3 - Poor	<b>Curbs:</b>	F2 - Fair
<b>Hand Rail:</b>	F1 - Fair	<b>Roadway Condition:</b>	P1 - Poor
<b>Approach Rail:</b>	F1 - Fair		
<b>Comments:</b>	Multiple areas near approach 1 with large potholes and exposed rebar on deck; no signs of water leaking through on underside. Both approach asphalt is in poor condition with large cracking and potholes. Water build up in between drainage points on left side of deck. Aluminum rail in fair condition with minor impact damage in some areas. Left side fascia has spalling with exposed rebar. Minor impact damage to guard rail.

<b>Next Rehab. Date:</b>	2028	<b>Replacement Year:</b>	2050
<b>Antic. Rehab. Cost:</b>	\$100,000	<b>Replacement Cost:</b>	\$3,000,000
<b>Recommendations:</b>	Previous Inspection - Upgrade guiderail post spacing near end blocks and remove overgrowth on approaches. Remove vegetation growth in deck drains. Replace expansion joints and re-chaulk curbs. Partial depth deck repair on various deck potholes. Consider waterproofing exposed concrete deck and paving if asphalt exists. Repave asphalt approaches.
