GOVERNMENT OF NEWFOUNDLAND AND LABRADOR Department of Transportation and Infrastructure	<b>BRIDGE INSPECTION REPORT</b> <b>B01302020-12</b>	
<b>Date:</b> 1/30/2020	<b>Inspected By:</b> Alex Ford	<b>Category:</b> Eng. - Engineering	
<b>BRIDGE INFORMATION</b>			
<b>Site:</b>	2-012 - LITTLE LAWN RIVER BRIDGE		
<b>Route:</b>	220	<b>Overall Length:</b>	18 m
<b>Year Built:</b>	1950	<b>Est:</b> No	<b>Overall Width:</b> 7 m
<b>Year Last Rehab.:</b>		<b>Est:</b> No	<b>Roadway Width:</b> 6.5 m
<b>Region:</b>	CENTRAL EAST	<b>Sidewalk Width:</b>	0 m
<b>Jurisdiction:</b>	Provincial	<b>Clearance to R.D. or N.W.L.:</b>	3 m
<b>Type of Structure:</b>	06 - Concrete Arch/TechSpan	<b>Max Depth of N.W.L.:</b>	1 m
<b>Purpose of Structure:</b>	04 - Over Non-Navigable Waters	<b>Spans:</b>	
<b>Type of Handrail:</b>	02 - Concrete Rail	<u>Span No.:</u>	<u>Length</u>
<b>Roadway Surface:</b>	01 - Concrete	1	15
<b>Alignment Vertical:</b>	01 - Good	2	0

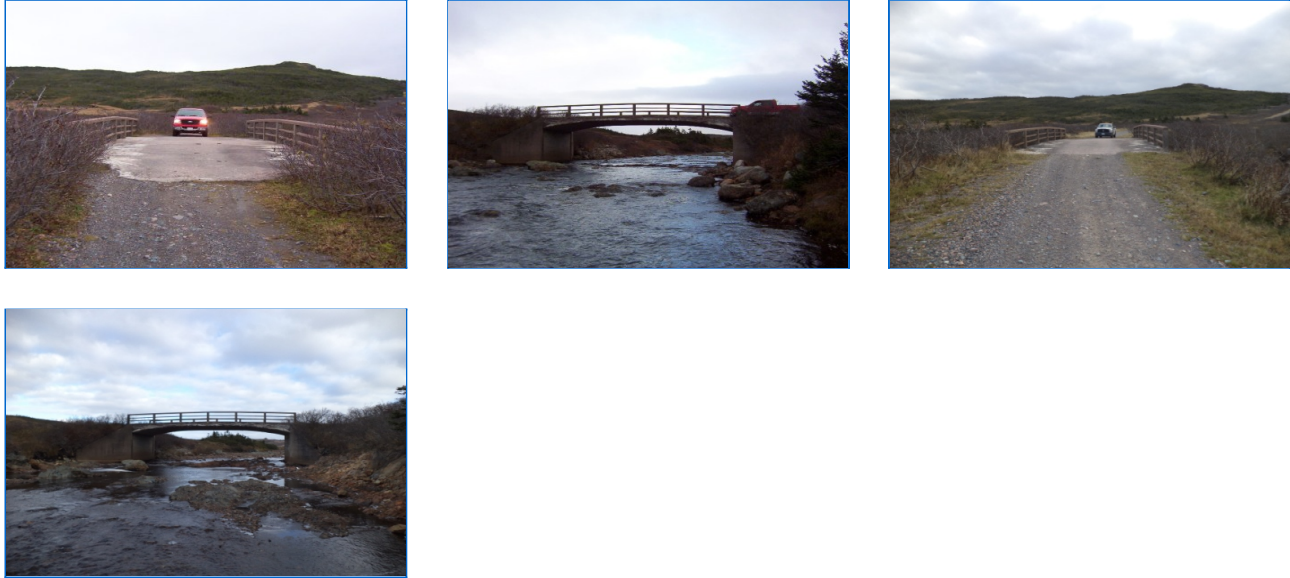
<b>SUBSTRUCTURE</b>			
<b>Condition:</b>	P - Poor	<b>Bearings:</b>	I - Inapplicable
		<b>Bearing Seat:</b>	I - Inapplicable
<b>Comments:</b>	Concrete abutments and wingwalls. Cracking with efflorescence over all, some disintegration of footing one. Wingwalls at abutment two are separating from the abutment - large cracks forming. Minor scour and concrete

erosion.			
<b>SUPERSTRUCTURE</b>			
<b>Condition:</b>	P3 - Poor	<b>Expansion Joints:</b>	I - Inapplicable
<b>Comments:</b>	Concrete arched deck slab. Underside of deck has some spalls, delaminations and exposed steel, cracking with efflorescence throughout.		
<b>DECK</b>			
<b>Condition:</b>	P3 - Poor	<b>Curbs:</b>	I - Inapplicable
<b>Hand Rail:</b>	P - Poor	<b>Roadway Condition:</b>	I - Inapplicable
<b>Approach Rail:</b>	I - Inapplicable		
<b>Comments:</b>	Exposed concrete deck with gravel approaches. Deck edges are cracked, disintegrated and have heavy efflorescence. Some cracks, spalls and missing sections on concrete hand rail, anchorages are suspect.		
<b>HYDROLOGY</b>			
<b>Water Velocity:</b>	0.5 m/s	<b>Ice Problem:</b>	N - No Problem
<b>Water Depth:</b>	0.5 m	<b>Scour Problem:</b>	K - Known Problem
<b>Waterway:</b>	01 - Adequate	<b>Debris Problem:</b>	N - No Problem
<b>Comments:</b>	Minor scour under all footings. Footings are on bedrock, no issues.

<b>REPLACEMENT/REHABILITATION</b>			
<b>Next Rehab. Date:</b>		<b>Replacement Year:</b>	
<b>Antic. Rehab. Cost:</b>	\$0	<b>Replacement Cost:</b>	\$0
<b>Recommendations:</b>	Structure is on old road between St. Lawrence and Lawn and is used by cabin owners and hunters. Bridge is suitable for this and can be left in place. Load limits should be posted.		
<b>OBSERVATIONS</b>			
<b>Overall Condition:</b>	P3 - Poor	<b>Requires Further Inspection:</b>	No
<b>Additional Observations:</b>	Located on the old road between St. Lawrence and Lawn. Access from R220 1.5km south of St. Lawrence and travel 3.4km on the gravel road. Bridge is also accessible from Lawn (gravel road near old school). Old bridge abutments located upstream (1925).		
<b>LEGEND:</b>			
<b>Condition Definitions:</b>		<b>Problem Definitions:</b>	
1 - *Good - [discontinued code].	F2 - Fair.	C - Unsafe (Closed to Public).	N - No Problem.
2 - *Fair - [discontinued code].	F1 - Fair.	U - Uninspectable.	P - Possible Problem.
