| | GOVERNMENT OF<br>NEWFOUNDLAND<br>AND LABRADOR<br>Department of Transportation and Infrastructure | <b>BRIDGE INSPECTION REPORT</b><br><b>B05192022-24</b> | |
| <b>Date:</b> 5/11/2021 | <b>Inspected By:</b> Butler | <b>Category:</b> Eng. - Engineering | |
| <b>Site:</b> | 2-012 - LITTLE LAWN RIVER BRIDGE | | |

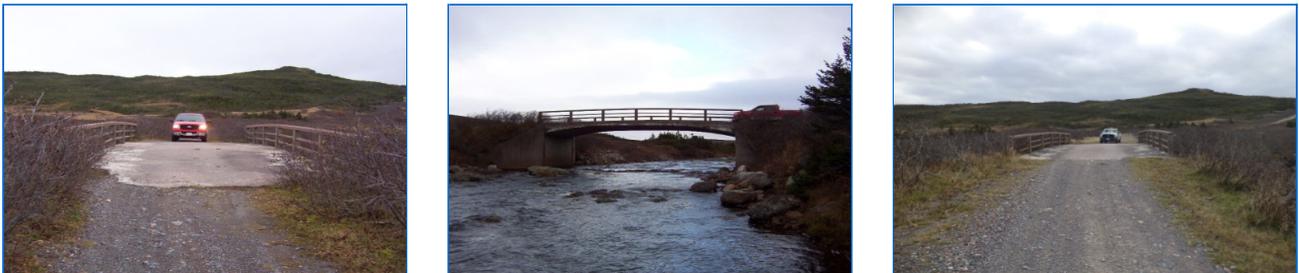
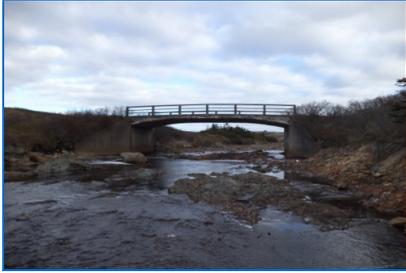
| <b>BRIDGE PHOTOS</b> | | | |

| <b>Comments:</b> | Concrete abutments and wingwalls. Cracking with efflorescence over all, some disintegration of footing one. | | |

| Wingwalls at abutment two are separating from the abutment - large cracks forming. Minor scour and concrete erosion. | | | |
| <b>Comments:</b> | Concrete arched deck slab. Underside of deck has some spalls, delaminations and exposed steel, cracking with efflorescence throughout. | | |
| <b>Comments:</b> | Exposed concrete deck with gravel approaches. Deck edges are cracked, disintegrated and have heavy efflorescence. Some cracks, spalls and missing sections on concrete hand rail, anchorages are suspect. | | |

| <b>Recommendations:</b> | Structure is on old road between St. Lawrence and Lawn and is used by cabin owners and hunters. Bridge is suitable for this and can be left in place. Load limits should be posted. | | |
