GOVERNMENT OF
NEWFOUNDLAND
AND LABRADOR
Department of Transportation and Infrastructure

BRIDGE INSPECTION REPORT
B08212024-2

Date: 8/20/2024

Site:	2-042 - LITTLE ST. LAWRENCE CAUSEWAY BRIDGE					
Route:	220	Overall Length:	43.3 m			
Year Built:	1971	Est: No	Overall Width:	10.5 m		
Year Last Rehab.:	2023	Est: No	Roadway Width:	9.3 m		
Region:	CENTRAL EAST		Sidewalk Width:	0 m		
Jurisdiction:	Provincial		Clearance to R.D. or N.W.L.:	3 m		
Type of Structure:	01 - AASH to Girder		Max Depth of N.W.L.:	2.5 m		
Purpose of Structure:	03 - Over Navigable Waters		Spans:			
Type of Handrail:	01 - Aluminum Rail		Span No.:	Length	Span No.:	Length
Roadway Surface:	02 - Asphalt		1	36.6	4	0
Alignment Vertical:	01 - Good		2	0	5	0
Alignment Horizontal:	01 - Good		3	0	6	0
Restrictions:	No

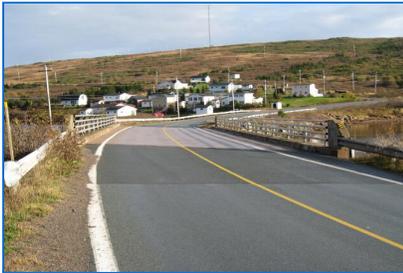
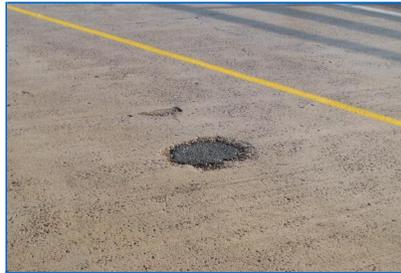
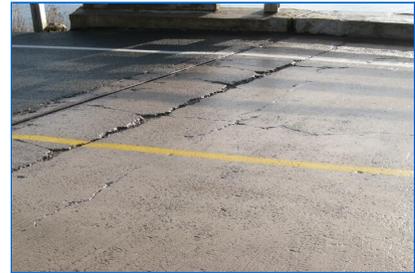
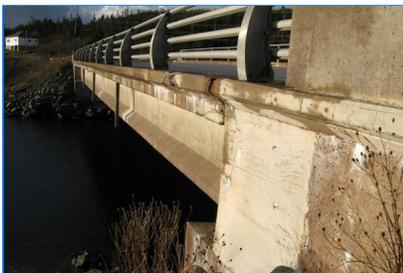
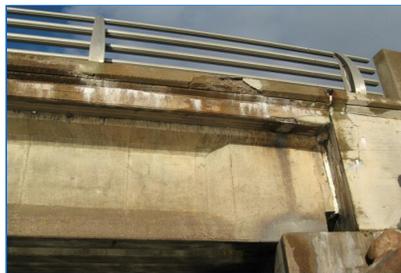
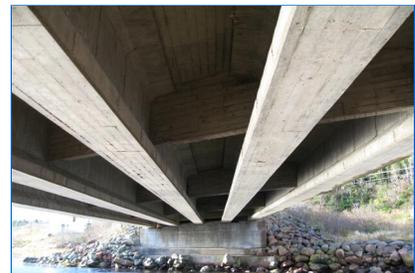
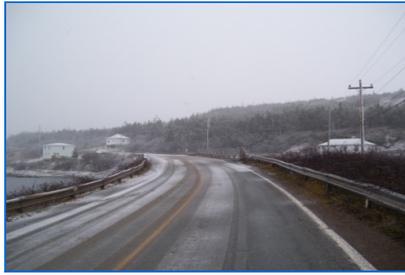
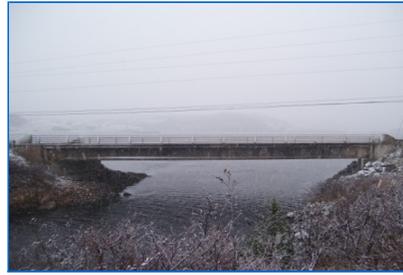
Condition:	F2 - Fair	Bearings:	P3 - Poor
		Bearing Seat:	P3 - Poor
Comments:	Concrete abutments and wingwalls with minor cracking throughout. Wingwalls have minor efflorescence deposits in location of cracks. Some bearings are squat and widely cracked. Bearing seats have large amounts of debris consisting of granular and formwork.

Condition:	F2 - Fair	Expansion Joints:	U - Uninspectable
Comments:	5 AASHTO girders, expansion joints paved over, likely new in 2023 rehab. Some girders have minor isolated spalling, overall in fair condition. Outside girder-ends appear to have attempted rehab surfaces but still some are deteriorated. All girder bottoms have damp staining.

Condition:	F2 - Fair	Curbs:	F1 - Fair
Hand Rail:	F2 - Fair	Roadway Condition:	F2 - Fair
Approach Rail:	F2 - Fair		
Comments:	Hazard markers are too small. Poor rehab surfaces on fascia, with noticeable edge of thin cover. some spalling/disintegration on fascia. deck soffit has areas of spalling and cracking with heavy amounts of efflorescence seeping through. Minor to moderate erosion on approaches near end blocks.

Water Velocity:	Tidal m/s	Ice Problem:	N - No Problem
Water Depth:	Tidal m	Scour Problem:	K - Known Problem
Waterway:	01 - Adequate	Debris Problem:	N - No Problem
Comments:	Tidal, velocity and depth fluctuate. minor scouring of abutment one. Old bridge structure littering just upstream with exposed rebar and wires. Could cause potential danger to waterway users.

Overall Condition:	F2 - Fair	Requires Further Inspection:	No
Additional Observations:	Monitor locations of seeping efflorescence through deck soffit, likely due to leftover formwork.
