GOVERNMENT OF NEWFOUNDLAND AND LABRADOR Department of Transportation and Infrastructure	BRIDGE INSPECTION REPORT B08302023-3	
Date: 8/10/2023	Inspected By: Darrell Avery	Category: Eng. - Engineering	
BRIDGE INFORMATION			
Site:	2-093 - LOCKSTON PARK BRIDGE #1		
Route:	236	Overall Length:	17.4 m
Year Built:	1991	Est: No	Overall Width: 10 m
Year Last Rehab.:		Est: No	Roadway Width: 9 m
Region:	CENTRAL EAST	Sidewalk Width:	0 m
Jurisdiction:	Provincial	Clearance to R.D. or N.W.L.:	1 m
Type of Structure:	03 - Reinforced Concrete Beam/Slab	Max Depth of N.W.L.:	1 m
Purpose of Structure:	04 - Over Non-Navigable Waters	Spans:	
Type of Handrail:	01 - Aluminum Rail	Span No.:	Length
Roadway Surface:	01 - Concrete	1	9
Alignment Vertical:	01 - Good	2	0
Alignment Horizontal:	01 - Good	3	0
Restrictions:	No	4	0
		5	0
		6	0
BRIDGE PHOTOS

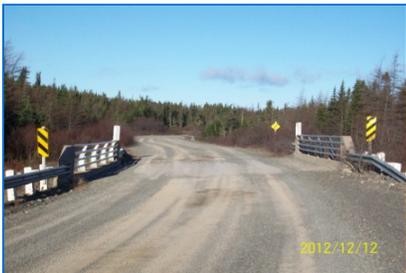
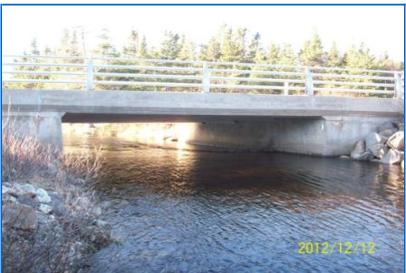
Comments:	Previous inspection - Concrete abutments and wing walls. Abutments have efflorescence on them. New inspection - Medium cracks at corners.		
SUPERSTRUCTURE			
Condition:	F2 - Fair	Expansion Joints:	I - Inapplicable
Comments:	Previous inspection - Some leaking at joints, evidence of leaking at curb soffit and abutments.		
DECK			
Condition:	F2 - Fair	Curbs:	F1 - Fair
	F2 - Fair		F2 - Fair

Hand Rail:		Roadway Condition:	
Approach Rail:	P1 - Poor		
Comments:	Previous inspection - Exposed concrete deck. Aluminum bridge rail. No michigan shoes. Brush growing over approach rails blocking hazard markers. Bridge deck has a buildup of gravel. All end blocks have cracks on them, Abutment #1 left end block has impact damage and non structural rail post missing. New inspection - Medium cracks on curb fascias. At abutment #1 left top aluminum bridge rail also damaged. Many approach guiderail posts have rotted and windrows of gravel at road shoulders.		
HYDROLOGY			
Water Velocity:	1 m/s	Ice Problem:	N - No Problem
Water Depth:	.7 m	Scour Problem:	N - No Problem
Waterway:	01 - Adequate	Debris Problem:	P - Possible Problem
Comments:	Beaver dam starting under bridge.		
REPLACEMENT/REHABILITATION			
Next Rehab. Date:		Replacement Year:	
Antic. Rehab. Cost:	\$tbd	Replacement Cost:	\$0
Recommendations:	Remove brush, repair bridge rail and new approach guiderail. Repair concrete surfaces. Remove beaver dam.
