GOVERNMENT OF NEWFOUNDLAND AND LABRADOR Department of Transportation and Infrastructure	<b>BRIDGE INSPECTION REPORT</b> <b>B08312023-1</b>	
<b>Date:</b> 8/10/2023	<b>Inspected By:</b> Darrell Avery	<b>Category:</b> Eng. - Engineering	
<b>BRIDGE INFORMATION</b>			
<b>Site:</b>	2-129 - LOCKSTON PARK BRIDGE #2		
<b>Route:</b>	236	<b>Overall Length:</b>	17.4 m
<b>Year Built:</b>	1991	<b>Est:</b> No	<b>Overall Width:</b> 10 m
<b>Year Last Rehab.:</b>		<b>Est:</b> No	<b>Roadway Width:</b> 9 m
<b>Region:</b>	CENTRAL EAST	<b>Sidewalk Width:</b>	0 m
<b>Jurisdiction:</b>	Provincial	<b>Clearance to R.D. or N.W.L.:</b>	1 m
<b>Type of Structure:</b>	03 - Reinforced Concrete Beam/Slab	<b>Max Depth of N.W.L.:</b>	1 m
<b>Purpose of Structure:</b>	04 - Over Non-Navigable Waters	<b>Spans:</b>	
<b>Type of Handrail:</b>	01 - Aluminum Rail	<b>Span No.:</b>	<b>Length</b>
<b>Roadway Surface:</b>	01 - Concrete	1	9
<b>Alignment Vertical:</b>	01 - Good	2	0

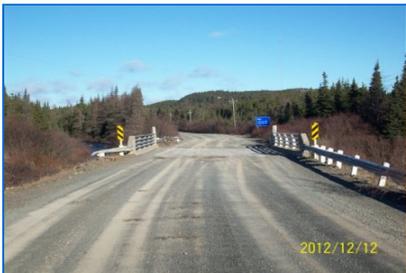
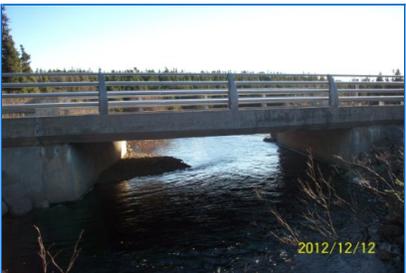
<b>SUBSTRUCTURE</b>			
<b>Condition:</b>	F2 - Fair	<b>Bearings:</b>	I - Inapplicable
		<b>Bearing Seat:</b>	U - Uninspectable
<b>Comments:</b>	Previous inspection - Concrete wing walls and abutments. Some efflorescence on abutments due to leaking joints. Abutments have a buildup of efflorescence. New inspection surface cracks at abutment corners.		
<b>SUPERSTRUCTURE</b>			
<b>Condition:</b>	F2 - Fair	<b>Expansion Joints:</b>	I - Inapplicable
<b>Comments:</b>	Previous inspection - Dymeric through curbs in poor condition.		
<b>DECK</b>			
<b>Condition:</b>	F2 - Fair	<b>Curbs:</b>	F1 - Fair
	F2 - Fair		F2 - Fair

<b>Hand Rail:</b>		<b>Roadway Condition:</b>	
<b>Approach Rail:</b>	P1 - Poor		
<b>Comments:</b>	Previous inspection - Exposed concrete deck has light cracking. Aluminum bridge rail with concrete end blocks. Significant light and medium cracking in end blocks. Significant cracking in curb fascia. Approach rail damaged at abutment 1 left side and abutment 2 on both sides. No Michigan shoes. Approach rail covered in brush. Abutment #2 end block has impact damage. Potholes on gravel approach at bridge deck. There is buildup of gravel on the deck. Abutment 2 has hole starting in concrete deck about 140mm in diameter and 35mm deep. New inspection - Deck developing more pot holes & top left aluminum bridge rail damaged. Approach guiderail posts are rotting.		
<b>HYDROLOGY</b>			
<b>Water Velocity:</b>	1 m/s	<b>Ice Problem:</b>	N - No Problem
<b>Water Depth:</b>	1 m	<b>Scour Problem:</b>	N - No Problem

<b>Waterway:</b>	01 - Adequate	<b>Debris Problem:</b>	N - No Problem
<b>Comments:</b>			
<b>REPLACEMENT/REHABILITATION</b>			
<b>Next Rehab. Date:</b>		<b>Replacement Year:</b>	
<b>Antic. Rehab. Cost:</b>	\$tbd	<b>Replacement Cost:</b>	\$tbd
<b>Recommendations:</b>	Repair approach rail. Repair Deck. Clear brush from approaches. Install hazard marker.		
<b>OBSERVATIONS</b>			
<b>Overall Condition:</b>	F2 - Fair	<b>Requires Further Inspection:</b>	No
<b>Additional Observations:</b>
