GOVERNMENT OF NEWFOUNDLAND AND LABRADOR Department of Transportation and Infrastructure	BRIDGE INSPECTION REPORT B11172023-8	
Date: 11/17/2023	Inspected By: Darrell Avery	Category: Eng. - Engineering	
BRIDGE INFORMATION			
Site:	2-120 - LONG HARBOUR BRIDGE		
Route:	202	Overall Length:	17.9 m
Year Built:	1960	Est: No	Overall Width: 13.2 m
Year Last Rehab.:		Est: No	Roadway Width: 11.8 m
Region:	CENTRAL EAST	Sidewalk Width:	0 m
Jurisdiction:	Provincial	Clearance to R.D. or N.W.L.:	1.2 m
Type of Structure:	04 - Rigid Frame	Max Depth of N.W.L.:	0.8 m
Purpose of Structure:	04 - Over Non-Navigable Waters		
Type of Handrail:	02 - Concrete Rail	Spans:	
Roadway Surface:	02 - Asphalt	Span No.:	Length
Alignment Vertical:	01 - Good	Span No.:	Length
Alignment Horizontal:	01 - Good	Span No.:	Length
Restrictions:	No		
BRIDGE PHOTOS

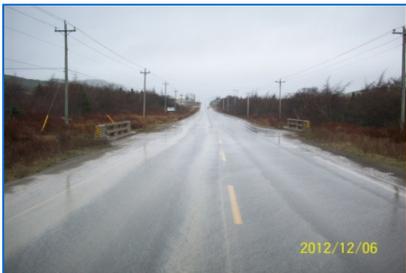
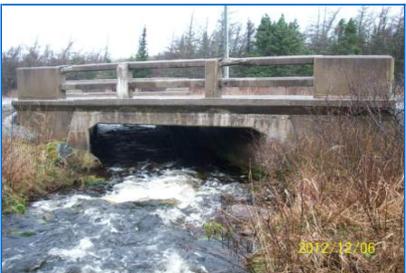
SUBSTRUCTURE			
Condition:	F2 - Fair	Bearings:	I - Inapplicable
		Bearing Seat:	I - Inapplicable

Comments:	Previous inspection - Some cracking with efflorescence in abutment and wing walls. Some erosion of the footings. Abutment one has concrete erosion at water line.		
SUPERSTRUCTURE			
Condition:	F2 - Fair	Expansion Joints:	I - Inapplicable
Comments:	Previous inspection - Medium cracking with efflorescence of the deck soffit. Some spalling and disintegration of the fascia.		
DECK			
Condition:	F2 - Fair	Curbs:	F2 - Fair

Hand Rail:	P1 - Poor	Roadway Condition:	F2 - Fair
Approach Rail:	I - Inapplicable		
Comments:	Previous inspection - No approach rail. Concrete deck with asphalt wearing surface. Concrete bridge rail and endblocks. Severe disintegration and spalling with exposed rebar on several areas of bridge rail and curb over abutment two. Abutment has a washout starting on the right side.		
HYDROLOGY			
Water Velocity:	1 m/s	Ice Problem:	N - No Problem
Water Depth:	0.5 m	Scour Problem:	N - No Problem
Waterway:	01 - Adequate	Debris Problem:	NA - Not Applicable
Comments:	Previous inspection - Bridge was previously overtopped.		
REPLACEMENT/REHABILITATION			
Next Rehab. Date:		Replacement Year:	
Antic. Rehab. Cost:	\$tbd	Replacement Cost:	\$tbd
Recommendations:			
OBSERVATIONS			
Overall Condition:	F2 - Fair	Requires Further Inspection:	No
Additional Observations:	Previous inspection - 20mm water line?? 3.5m downstream of structure in stream bed.
