GOVERNMENT OF NEWFOUNDLAND AND LABRADOR Department of Transportation and Infrastructure	BRIDGE INSPECTION REPORT B04282021-19	
Date: 4/28/2021	Inspected By: Butler	Category: Eng. - Engineering	
BRIDGE INFORMATION			
Site:	2-057 - MIDDLE BROOK BRIDGE		
Route:	233-13	Overall Length:	35 m
Year Built:	1972	Est: No	Overall Width: 12 m
Year Last Rehab.:	1998	Est: No	Roadway Width: 9.7 m
Region:	CENTRAL EAST	Sidewalk Width:	1.2 m
Jurisdiction:	Provincial	Clearance to R.D. or N.W.L.:	4 m
Type of Structure:	01 - AASH to Girder	Max Depth of N.W.L.:	1 m
Purpose of Structure:	04 - Over Non-Navigable Waters		
Type of Handrail:	01 - Aluminum Rail	Spans:	
Roadway Surface:	02 - Asphalt	<u>Span No.:</u>	<u>Length</u>
Alignment Vertical:	01 - Good	1	24
Alignment Horizontal:	01 - Good	2	0
Restrictions:	No	3	0
		<u>Span No.:</u>	<u>Length</u>
		4	0
		5	0
		6	0
BRIDGE PHOTOS

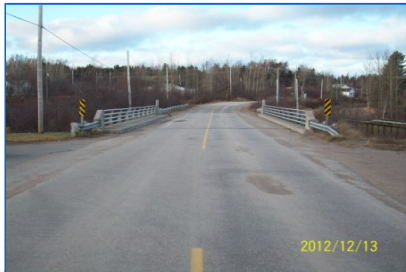
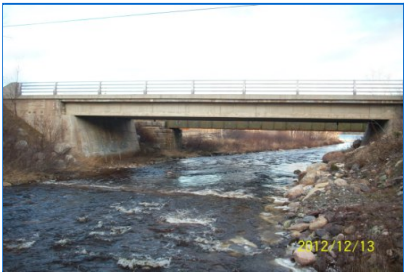
Bearing Seat:	F2 - Fair
Comments:	Concrete abutments and wing walls. Light to medium cracking and some scaling throughout. Elastomeric bearings.		
SUPERSTRUCTURE			
Condition:	F2 - Fair	Expansion Joints:	F2 - Fair
Comments:	Six AASHTO girders. Some spalling of girder ends. Asphalt plug joints. Dymeric through curbs poor condition.		
DECK			
Condition:	F2 - Fair	Curbs:	F2 - Fair
Hand Rail:	F2 - Fair	Roadway Condition:	F2 - Fair

Comments: Asphalt wearing surface has large potholes, raveling and exposed concrete deck, some ACP patchwork has been done. Light cracking and scaling of curb and sidewalk, sidewalk has no ramps. Soffit has light cracking with several spalls. Aluminum bridge rail with concrete end blocks. Right abutment 2 has impact damage. Object marker abutment 2 left side is missing. Bottom of deck spalling in multiple places exposing rebar in places. The concrete curb is failing where it was poured during joint installation.

Recommendations: Repair asphalt wearing surface with repave. Repair dymeric at curbs. Replace hazard marker abutment 2 left side. monitor and repair spalling deck bottom, replace concrete around expansion joints.
