GOVERNMENT OF NEWFOUNDLAND AND LABRADOR Department of Transportation and Infrastructure	BRIDGE INSPECTION REPORT B08052024-3	
Date: 7/26/2024	Inspected By: D. Burns/J. Rowe	Category: Eng. - Engineering	
BRIDGE INFORMATION			
Site:	2-057 - MIDDLE BROOK BRIDGE		
Route:	233-13	Overall Length:	35 m
Year Built:	1972	Est: No	Overall Width: 12 m
Year Last Rehab.:	1998	Est: No	Roadway Width: 9.7 m
Region:	CENTRAL EAST	Sidewalk Width:	1.2 m
Jurisdiction:	Provincial	Clearance to R.D. or N.W.L.:	4 m
Type of Structure:	01 - AASH to Girder	Max Depth of N.W.L.:	1 m
Purpose of Structure:	04 - Over Non-Navigable Waters		
Type of Handrail:	01 - Aluminum Rail	Spans:	
Roadway Surface:	02 - Asphalt	Span No.:	Length
Alignment Vertical:	01 - Good	Span No.:	Length
Alignment Horizontal:	01 - Good	Span No.:	Length
Restrictions:	No	Span No.:	Length
		1	24
		2	0
		3	0
		4	0
		5	0
		6	0
BRIDGE PHOTOS

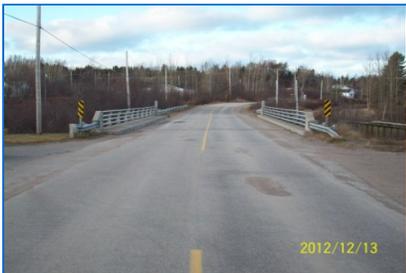
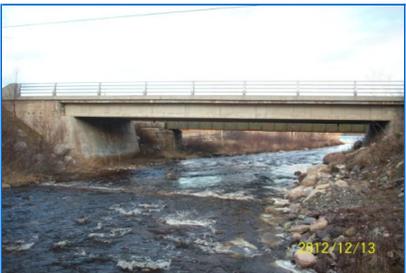
Bearing Seat:	F2 - Fair
Comments:	Light cracking throughout concrete abutments and wingwalls. Abutment 2 has significant vertical crack, also has efflorescence staining near footing. Wingwall 1 left has efflorescence staining under large hole on outside curb. Bearing pads appear to be squat in some areas, but too high for thorough inspection.		
SUPERSTRUCTURE			
Condition:	F2 - Fair	Expansion Joints:	P1 - Poor
Comments:	Six AASHTO girders with some locations of minor rust staining. Some girder ends have minor spalling. Expansion joints are plugged with asphalt and have gouges in some areas, likely from the snow plow. Curb section of expansions joints are severely disintegrated, and dimeric seal is in poor condition.		
DECK

Condition:	P3 - Poor	Curbs:	P3 - Poor
Hand Rail:	F2 - Fair	Roadway Condition:	P3 - Poor
Approach Rail:	P3 - Poor		
Comments:	Large section of pothole in asphalt surface on left side of deck. Some patchwork has been done, but more potholes are appearing. Large gouges taken from asphalt in some areas, likely from snow plow. Curbs have light cracking throughout and are in poor condition around expansion joints. Underside of deck has areas of severe spalling/delamination with the worst area being between girders 2 and 3 near abutment 1 before the diaphragm. Underside of deck appears to have exposed rebar with rust staining in some areas. Hazard markers are either missing or damaged. Sidewalk has no ramps. End blocks have minor to moderate cracking throughout. Structural posts are showing signs of rot. Approach 1 left has guard rail detached from post.		
HYDROLOGY			
Water Velocity:	0.5 m/s	Ice Problem:	N - No Problem

Water Depth:	0.5 m	Scour Problem:	N - No Problem
Waterway:	01 - Adequate	Debris Problem:	N - No Problem
Comments:	Repair asphalt surface. Repair hazard markers as well as implement new structural post with correct spacing. Repair/monitor large areas of spalling on underside of deck. Repair expansion joints areas, specifically concrete curb sections and dimeric seals.		
REPLACEMENT/REHABILITATION			
Next Rehab. Date:		Replacement Year:	
Antic. Rehab. Cost:	\$TBD	Replacement Cost:	\$TBD
Recommendations:	Repair asphalt surface. Repair hazard markers as well as implement new structural post with correct spacing. Repair/monitor large areas of spalling on underside of deck. Repair expansion joints areas, specifically concrete curb sections and dimeric seals.		
OBSERVATIONS			
Overall Condition:	F1 - Fair	Requires Further Inspection:	No
Additional Observations:
