GOVERNMENT OF NEWFOUNDLAND AND LABRADOR Department of Transportation and Infrastructure	BRIDGE INSPECTION REPORT B04282021-4	
Date: 4/20/2021	Inspected By: Butler	Category: Eng. - Engineering	
BRIDGE INFORMATION			
Site:	TCH-029 - MIDDLE BROOK BRIDGE (SQUARE POND)		
Route:	1	Overall Length:	28 m
Year Built:	1952	Est: Yes	Overall Width: 13.4 m
Year Last Rehab.:	1990	Est: No	Roadway Width: 12 m
Region:	CENTRAL EAST	Sidewalk Width:	0 m
Jurisdiction:	Provincial	Clearance to R.D. or N.W.L.:	4 m
Type of Structure:	13 - Other	Max Depth of N.W.L.:	0.5 m
Purpose of Structure:	04 - Over Non-Navigable Waters		
Type of Handrail:	01 - Aluminum Rail	Spans:	
Roadway Surface:	02 - Asphalt	<u>Span No.:</u>	<u>Length</u>
Alignment Vertical:	01 - Good	1	26
Alignment Horizontal:	01 - Good	2	0
Restrictions:	No	3	0
		<u>Span No.:</u>	<u>Length</u>
		4	0
		5	0
		6	0
BRIDGE PHOTOS

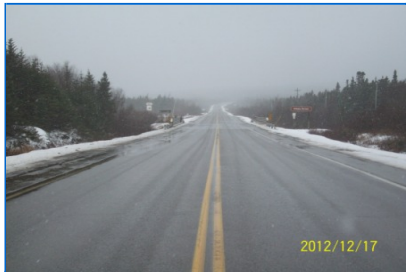
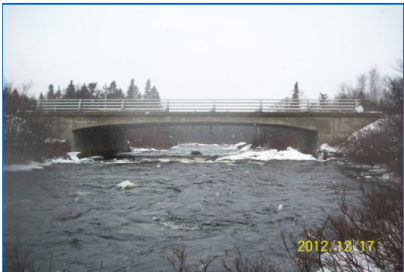
Bearing Seat:	I - Inapplicable
Comments:	Concrete abutments and wing walls. Abutment two has concrete erosion at the normal water line. Wing walls have light cracking, spalling and exposed rebar. Structure widened left and right for TCH widening. Gabion retaining walls all four corners. Gabion wall at abutment one left side is gone, gabion abutment 2 right side has no wire remaining in the basket below the high water line. There is a longitudinal crack along the middle of the entire structure at the construction joint, there are 3 other small cracks running parallel to this one. Abutment 2 right has scour. Abutment 2 left has concrete erosion/scour between the footing and abutment 150mm to 200mm deep, 3000mm long and 60mm wide.		
SUPERSTRUCTURE			
Condition:	F2 - Fair	Expansion Joints:	I - Inapplicable
Comments:	Arch rigid frame. Soffit in good condition, cracking along fascia.

DECK			
Condition:	F2 - Fair	Curbs:	F2 - Fair
Hand Rail:	F2 - Fair	Roadway Condition:	F2 - Fair
Approach Rail:	P3 - Poor		
Comments:	Asphalt wearing surface resurfaced in 2016 has ponding over Abutment 2 left. Aluminum 4 rail system with concrete end blocks. Both right side end blocks have cracking, disintegration and exposed rebar. Left side end blocks have light cracking. Approach guide rail has no end shoes at end blocks and is not structural rail.		
HYDROLOGY			
Water Velocity:	1.5 m/s	Ice Problem:	N - No Problem
Water Depth:	.5 m	Scour Problem:	K - Known Problem
Waterway:	01 - Adequate	Debris Problem:	N - No Problem
Comments:			
REPLACEMENT/REHABILITATION			
Next Rehab. Date:		Replacement Year:	
Antic. Rehab. Cost:	\$65000	Replacement Cost:	\$0
Recommendations:	Rehabilitate deck. Repair or replace right side end blocks. Replace all gabion walls. Replace guide rail with structural rail and end shoes. Repair scour below footing and abutment.
