GOVERNMENT OF NEWFOUNDLAND AND LABRADOR Department of Transportation and Infrastructure	BRIDGE INSPECTION REPORT B04282021-17	
Date: 4/22/2021	Inspected By: Butler	Category: Eng. - Engineering	
BRIDGE INFORMATION			
Site:	TCH-022 - MIDDLE BROOK CULVERT		
Route:	1	Overall Length:	20 m
Year Built:	1965	Est: No	Overall Width: 45 m
Year Last Rehab.:		Est: No	Roadway Width: 20 m
Region:	CENTRAL EAST	Sidewalk Width:	0 m
Jurisdiction:	Provincial	Clearance to R.D. or N.W.L.:	4 m
Type of Structure:	04 - Rigid Frame	Max Depth of N.W.L.:	1 m
Purpose of Structure:	04 - Over Non-Navigable Waters		
Type of Handrail:	06 - None	Spans:	
Roadway Surface:	02 - Asphalt	<u>Span No.:</u>	<u>Length</u>
Alignment Vertical:	01 - Good	1	11
Alignment Horizontal:	01 - Good	2	0
Restrictions:	No	3	0
		<u>Span No.:</u>	<u>Length</u>
		4	0
		5	0
		6	0
BRIDGE PHOTOS

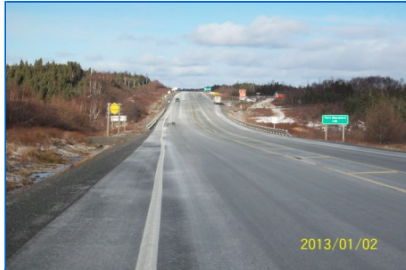
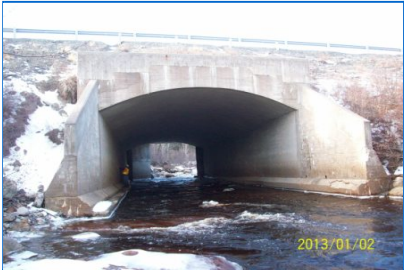
Bearing Seat:	I - Inapplicable
Comments:	Rigid frame structure. Concrete footings, abutments and wing walls. Footings have erosion and severe scaling. Some areas of disintegration with exposed rebar above footing near abutment one from erosion. Wing walls right side has medium map cracking throughout. Parapet wall right side significant amount of cracking. Some cracking of abutment walls, severe on the outside, minor inside. Severe vertical crack abutment one. Abutment #2 left has severe concrete erosion adjacent to the extension. Approximately 100mm to 300mm deep exposing rebar.		
SUPERSTRUCTURE			
Condition:	F2 - Fair	Expansion Joints:	I - Inapplicable
Comments:	Some light cracking and efflorescence throughout soffit. Leakage through longitudinal construction joint left side where structure was widened.		
DECK

Condition:	U - Uninspectable	Curbs:	I - Inapplicable
Hand Rail:	I - Inapplicable	Roadway Condition:	I - Inapplicable
Approach Rail:	I - Inapplicable		
Comments:	Approximately five metres of fill over rigid frame. Standard type guide rail left and right on TCH in good condition. Shoulder washout on TCH both sides approximately 800mm deep.		
HYDROLOGY			
Water Velocity:	1.5 m/s	Ice Problem:	N - No Problem
Water Depth:	.5 m	Scour Problem:	K - Known Problem
Waterway:	01 - Adequate	Debris Problem:	N - No Problem
Comments:	Abutment #1 is scoured approximately 100mm to 300mm deep throughout its length. Abutment #2 is scoured approximately 500mm deep by 1500mm long on the left side adjacent to the extension.		
REPLACEMENT/REHABILITATION			
Next Rehab. Date:		Replacement Year:	
Antic. Rehab. Cost:	\$0	Replacement Cost:	\$0
Recommendations:	Place Rehab on list for extensive concrete work to repair scour, concrete erosion and cracking. Repair shoulder washouts.
