GOVERNMENT OF NEWFOUNDLAND AND LABRADOR Department of Transportation and Infrastructure	BRIDGE INSPECTION REPORT B08012024-3	
Date: 7/26/2024	Inspected By: D. Burns/J. Rowe	Category: Eng. - Engineering	
BRIDGE INFORMATION			
Site:	TCH-022 - MIDDLE BROOK BRIDGE		
Route:	1	Overall Length:	20 m
Year Built:	1965	Est: No	Overall Width: 45 m
Year Last Rehab.:		Est: No	Roadway Width: 20 m
Region:	CENTRAL EAST	Sidewalk Width:	0 m
Jurisdiction:	Provincial	Clearance to R.D. or N.W.L.:	4 m
Type of Structure:	04 - Rigid Frame	Max Depth of N.W.L.:	1 m
Purpose of Structure:	04 - Over Non-Navigable Waters		
Type of Handrail:	06 - None	Spans:	
Roadway Surface:	02 - Asphalt	<u>Span No.:</u>	<u>Length</u>
Alignment Vertical:	01 - Good	1	11
Alignment Horizontal:	01 - Good	2	0
Restrictions:	No	3	0
		4	0
		5	0
		6	0
BRIDGE PHOTOS

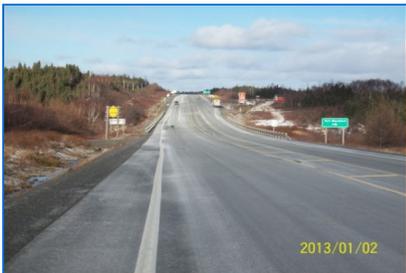
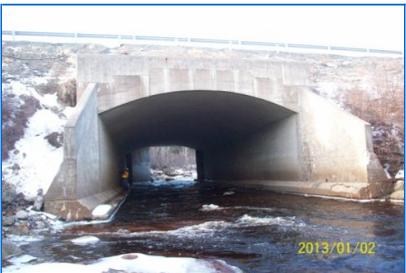
Comments:	Rigid frame structure complete with appropriate wingwalls and abutments. Left side of structure appears top be extended and leaking through the joint where the two structures connect. All wingwalls have cracking with efflorescence seeping through, right side wingwalls are worse than left. Right side parapet also has cracking throughout. All drainage holes are causing visible erosion and staining. Abutment 2 has location of exposed rebar near footing and concrete material has been lost; approximately 1 meter wide and 50mm tall. Approximately 100mm deep.		
SUPERSTRUCTURE			
Condition:	F2 - Fair	Expansion Joints:	I - Inapplicable
Comments:	Leakage between extension joint, with algae and efflorescence staining. Light cracking and efflorescence through soffit. Minor honeycombing of arch.

DECK			
Condition:	F2 - Fair	Curbs:	I - Inapplicable
Hand Rail:	I - Inapplicable	Roadway Condition:	F2 - Fair
Approach Rail:	I - Inapplicable		
Comments:	Roadway condition is fair, guard rail on either side of roadway in good condition also. Washout on right side shoulder approximately 1 meter deep.		
HYDROLOGY			
Water Velocity:	0.5 m/s	Ice Problem:	N - No Problem
Water Depth:	0.5 m	Scour Problem:	K - Known Problem
Waterway:	01 - Adequate	Debris Problem:	NA - Not Applicable
Comments:	Abutments have scouring in most areas.		
REPLACEMENT/REHABILITATION			
Next Rehab. Date:		Replacement Year:	
Antic. Rehab. Cost:	\$TBD	Replacement Cost:	\$TBD
Recommendations:	Repair scouring, substructure cracking, and right side shoulder washout.		
OBSERVATIONS			
Overall Condition:	F2 - Fair	Requires Further Inspection:	No
Additional Observations:
