GOVERNMENT OF NEWFOUNDLAND AND LABRADOR Department of Transportation and Infrastructure	BRIDGE INSPECTION REPORT B09012023-6	
Date: 8/21/2023	Inspected By: Darrell Avery	Category: Eng. - Engineering	
BRIDGE INFORMATION			
Site:	2-130 - MONROE BRIDGE		
Route:	232	Overall Length:	27 m
Year Built:	1968	Est: No	Overall Width: 7.6 m
Year Last Rehab.:		Est: No	Roadway Width: 7 m
Region:	CENTRAL EAST	Sidewalk Width:	0 m
Jurisdiction:	Provincial	Clearance to R.D. or N.W.L.:	6 m
Type of Structure:	11 - Timber Bridge	Max Depth of N.W.L.:	1 m
Purpose of Structure:	04 - Over Non-Navigable Waters	Spans:	
Type of Handrail:	06 - None	Span No.:	Length
Roadway Surface:	03 - Timber	1	6
Alignment Vertical:	02 - Adequate	2	0
Alignment Horizontal:	03 - Poor	3	0
Restrictions:	No	Span No.:	Length
		4	0
		5	0
		6	0
BRIDGE PHOTOS

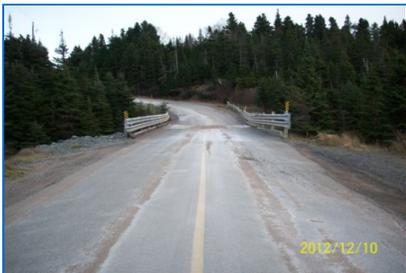
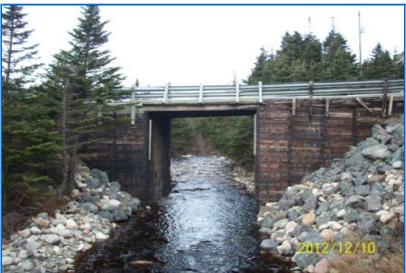
SUBSTRUCTURE			
Condition:	F2 - Fair	Bearings:	I - Inapplicable
		Bearing Seat:	F1 - Fair
Comments:	Creosote timber cribs forming abutments and wing walls. Abut. #1 right side repaired with PT timber previously. 2022 rehab project involved; abut. #2 right side - replacing approx. 12m long x 1m high section of 6x6 PT timbers & abut. #1 & #2 left timbers replaced - similar. New rip-rap at abut. #2 left spill slope. Both abutment face timbers in fair condition, F1. Beams extend back through the face and bearing timbers appear in fair condition, F1.

SUPERSTRUCTURE			
Condition:	F1 - Fair	Expansion Joints:	I - Inapplicable
Comments:	Previous inspection - Bottom of deck timbers and 12x12 timber beams appear in to be in fair condition, F1.		
DECK

Condition:	F2 - Fair	Curbs:	F2 - Fair
Hand Rail:	G - Good	Roadway Condition:	F2 - Fair
Approach Rail:	G - Good		
Comments:	2022 rehab project included the following; new chesses including extended members for bracing. new double flex beam bridge rails including intermediate support posts, new timber curbs, new section of timber raceway, new approach asphalt & new approach guiderail.		
HYDROLOGY			
Water Velocity:	0.3 m/s	Ice Problem:	N - No Problem
Water Depth:	0.3 m	Scour Problem:	N - No Problem
Waterway:	01 - Adequate	Debris Problem:	N - No Problem
Comments:			
REPLACEMENT/REHABILITATION			
Next Rehab. Date:		Replacement Year:	
Antic. Rehab. Cost:	\$	Replacement Cost:	\$1200000
Recommendations:	Previous inspection - Recommend a replacement from creosote environmental concerns. Structure has heavy creosote leakage and can been seen on river rock below		
OBSERVATIONS			
Overall Condition:	F2 - Fair	Requires Further Inspection:	No
