GOVERNMENT OF NEWFOUNDLAND AND LABRADOR Department of Transportation and Infrastructure	<b>BRIDGE INSPECTION REPORT</b> <b>B05122021-8</b>	
<b>Date:</b> 4/27/2021	<b>Inspected By:</b> Butler	<b>Category:</b> Eng. - Engineering	
<b>BRIDGE INFORMATION</b>			
<b>Site:</b>	2-203 - MONROE BRIDGE (OLD)		
<b>Route:</b>	232	<b>Overall Length:</b>	10 m
<b>Year Built:</b>	1945	<b>Est: Yes</b>	<b>Overall Width:</b> 5.3 m
<b>Year Last Rehab.:</b>		<b>Est: No</b>	<b>Roadway Width:</b> 0 m
<b>Region:</b>	CENTRAL EAST	<b>Sidewalk Width:</b>	0 m
<b>Jurisdiction:</b>	Provincial	<b>Clearance to R.D. or N.W.L.:</b>	2 m
<b>Type of Structure:</b>	05 - Pre-stressed Concrete Slab	<b>Max Depth of N.W.L.:</b>	1 m
<b>Purpose of Structure:</b>	04 - Over Non-Navigable Waters	<b>Spans:</b>	
<b>Type of Handrail:</b>	02 - Concrete Rail	<u>Span No.:</u>	<u>Length</u>
<b>Roadway Surface:</b>	01 - Concrete	1	6
<b>Alignment Vertical:</b>	03 - Poor	2	0

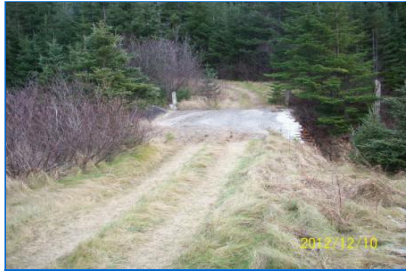
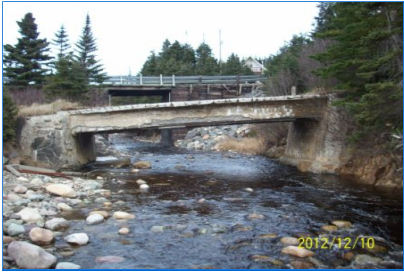
<b>SUBSTRUCTURE</b>			
<b>Condition:</b>	C - Unsafe (Closed to Public)	<b>Bearings:</b>	C - Unsafe (Closed to Public)
		<b>Bearing Seat:</b>	C - Unsafe (Closed to Public)
<b>Comments:</b>	Concrete abutments and wing walls. Severe disintegration of all.		
<b>SUPERSTRUCTURE</b>			
<b>Condition:</b>	C - Unsafe (Closed to Public)	<b>Expansion Joints:</b>	C - Unsafe (Closed to Public)
<b>Comments:</b>	Three 350mm x 700mm concrete beams. Severe disintegration and delamination of exterior beams. Centre beam has severe cracking with efflorescence. Soffit has cracking with efflorescence, severe disintegration of exterior soffit.		
<b>DECK</b>			
<b>Condition:</b>	C - Unsafe (Closed to Public)	<b>Curbs:</b>	C - Unsafe (Closed to Public)

<b>Hand Rail:</b>	C - Unsafe (Closed to Public)	<b>Roadway Condition:</b>	C - Unsafe (Closed to Public)
<b>Approach Rail:</b>	C - Unsafe (Closed to Public)		
<b>Comments:</b>	Bridge rail missing. Severe scaling and delamination of deck with severe disintegration and exposed rebar along the edges.

<b>Water Velocity:</b>	1 m/s	<b>Ice Problem:</b>	N - No Problem
<b>Water Depth:</b>	0.5 m	<b>Scour Problem:</b>	K - Known Problem
<b>Waterway:</b>	01 - Adequate	<b>Debris Problem:</b>	N - No Problem
<b>Comments:</b>	Scour under abutment one and two.

<b>Next Rehab. Date:</b>		<b>Replacement Year:</b>	
<b>Antic. Rehab. Cost:</b>	\$0	<b>Replacement Cost:</b>	\$0
<b>Recommendations:</b>	Remove structure.
