GOVERNMENT OF NEWFOUNDLAND AND LABRADOR Department of Transportation and Infrastructure	BRIDGE INSPECTION REPORT B10102023-9	
Date: 10/5/2023	Inspected By: Darrell Avery	Category: Eng. - Engineering	
BRIDGE INFORMATION			
Site:	2-203 - MONROE BRIDGE (OLD)		
Route:	232	Overall Length:	10 m
Year Built:	1945	Est: Yes	Overall Width: 5.3 m
Year Last Rehab.:		Est: No	Roadway Width: 0 m
Region:	CENTRAL EAST		Sidewalk Width: 0 m
Jurisdiction:	Provincial		Clearance to R.D. or N.W.L.: 2 m
Type of Structure:	05 - Pre-stressed Concrete Slab		Max Depth of N.W.L.: 1 m
Purpose of Structure:	04 - Over Non-Navigable Waters	Spans:	
Type of Handrail:	02 - Concrete Rail	Span No.:	Length
Roadway Surface:	01 - Concrete	Span No.:	Length
Alignment Vertical:	03 - Poor	1	6
Alignment Horizontal:	03 - Poor	2	0
Restrictions:	Yes	3	0
Describe Restrictions:	Old structure - Not in use.		
BRIDGE PHOTOS

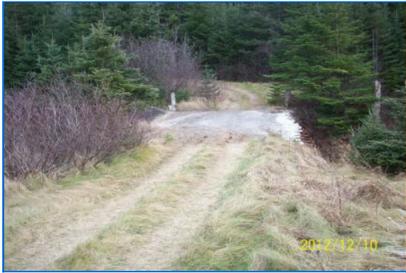
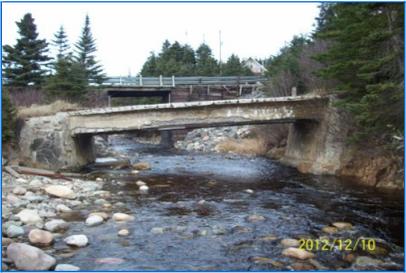
Bearing Seat:	C - Unsafe (Closed to Public)
Comments:	Concrete abutments and wing walls. Severe disintegration of all.		
SUPERSTRUCTURE			
Condition:	C - Unsafe (Closed to Public)	Expansion Joints:	C - Unsafe (Closed to Public)
Comments:	Three 350mm x 700mm concrete beams. Severe disintegration and delamination of exterior beams. Centre beam has severe cracking with efflorescence. Soffit has cracking with efflorescence, severe disintegration of exterior soffit.		
DECK			
Condition:	C - Unsafe (Closed to Public)	Curbs:	C - Unsafe (Closed to Public)

Hand Rail:	C - Unsafe (Closed to Public)	Roadway Condition:	C - Unsafe (Closed to Public)
Approach Rail:	C - Unsafe (Closed to Public)		
Comments:	Bridge rail missing. Severe scaling and delamination of deck with severe disintegration and exposed rebar along the edges.		
HYDROLOGY			
Water Velocity:	1 m/s	Ice Problem:	N - No Problem
Water Depth:	.5 m	Scour Problem:	K - Known Problem
Waterway:	01 - Adequate	Debris Problem:	N - No Problem
Comments:	Scour under abutment one and two.		
REPLACEMENT/REHABILITATION			
Next Rehab. Date:		Replacement Year:	
Antic. Rehab. Cost:	\$0	Replacement Cost:	\$0
Recommendations:	Remove structure.		
OBSERVATIONS			
Overall Condition:	C - Unsafe (Closed to Public)	Requires Further Inspection:	No
Additional Observations:	Structure is accessible and is used by ATV's.
