GOVERNMENT OF NEWFOUNDLAND AND LABRADOR Department of Transportation and Infrastructure	BRIDGE INSPECTION REPORT B09012023-2	
Date: 8/21/2023	Inspected By: Darrell Avery	Category: Eng. - Engineering	
BRIDGE INFORMATION			
Site:	2-207 - MORLEY'S SIDING TIMBER BRIDGE		
Route:	230-10-1	Overall Length:	12 m
Year Built:	1970	Est: Yes	Overall Width: 7 m
Year Last Rehab.:		Est: No	Roadway Width: 5.7 m
Region:	CENTRAL EAST	Sidewalk Width:	0 m
Jurisdiction:	Provincial	Clearance to R.D. or N.W.L.:	1.2 m
Type of Structure:	11 - Timber Bridge	Max Depth of N.W.L.:	0.5 m
Purpose of Structure:	04 - Over Non-Navigable Waters	Spans:	
Type of Handrail:	03 - Timber Rail	Span No.:	Length
Roadway Surface:	03 - Timber	1	7.5
Alignment Vertical:	01 - Good	2	0
Alignment Horizontal:	01 - Good	3	0
Restrictions:	No	4	0
		5	0
		6	0
BRIDGE PHOTOS

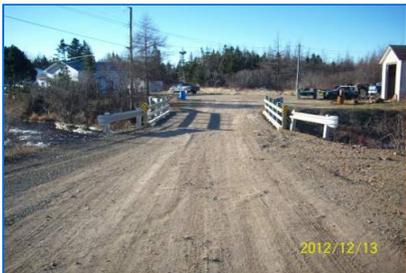
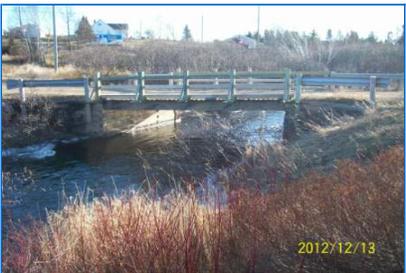
Comments:	Previous inspection - Closed face creosote timber abutments and wing walls. Some light cracking and decay. Wing wall abutment one right side leaning. Minor scouring on left side of abutment 1. New inspection - Abut. #2 wingwall - loose rail posts brackets.		
SUPERSTRUCTURE			
Condition:	F2 - Fair	Expansion Joints:	I - Inapplicable
Comments:	Previous inspection - 7 - 300mm x 450mm creosote timber beams. Some light longitudinal cracking.		
DECK			
Condition:	F2 - Fair	Curbs:	P1 - Poor

Hand Rail:	F2 - Fair	Roadway Condition:	P1 - Poor
Approach Rail:	P - Poor		
Comments:	Previous inspection - 75mm x 150mm creosote timber chesses. One chess broken near abutment two. 50mm timber wearing surface. 150mm x 150mm timber curb. One section of bridge rail and curb on right side broken and detached from bridge. Wood bridge rail. Object markers missing on abutment two. New inspection - right side broken (at deck edge) chesses are extended and form part of bridge rail bracing. Approach guiderail missing bolts.		
HYDROLOGY			
Water Velocity:	1 m/s	Ice Problem:	N - No Problem
Water Depth:	1 m	Scour Problem:	P - Possible Problem
Waterway:	01 - Adequate	Debris Problem:	N - No Problem
Comments:	Overtopped during Hurricane Igor.		
REPLACEMENT/REHABILITATION			
Next Rehab. Date:		Replacement Year:	
Antic. Rehab. Cost:	\$0	Replacement Cost:	\$0
Recommendations:	Repair broken curb and rail including extended chesses. Repair right side wingwalls.
