GOVERNMENT OF NEWFOUNDLAND AND LABRADOR Department of Transportation and Infrastructure	BRIDGE INSPECTION REPORT B06182024-3	
Date: 6/18/2024	Inspected By: Damien Burns	Category: Eng. - Engineering	
BRIDGE INFORMATION			
Site:	2-177 - NORTH HARBOUR BRIDGE (OLD)		
Route:	210	Overall Length:	12 m
Year Built:	1950	Est: Yes	Overall Width: 6 m
Year Last Rehab.:		Est: No	Roadway Width: 5.5 m
Region:	CENTRAL EAST	Sidewalk Width:	0 m
Jurisdiction:	Provincial	Clearance to R.D. or N.W.L.:	3 m
Type of Structure:	03 - Reinforced Concrete Beam/Slab	Max Depth of N.W.L.:	1 m
Purpose of Structure:	04 - Over Non-Navigable Waters	Spans:	
Type of Handrail:	03 - Timber Rail	<u>Span No.:</u>	<u>Length</u>
Roadway Surface:	01 - Concrete	1	6
Alignment Vertical:	01 - Good	2	0
Alignment Horizontal:	01 - Good	3	0
Restrictions:	Yes	4	0
Describe Restrictions:	Approach sign "This road not maintained by Dept. Of Trans. Use at own risk"

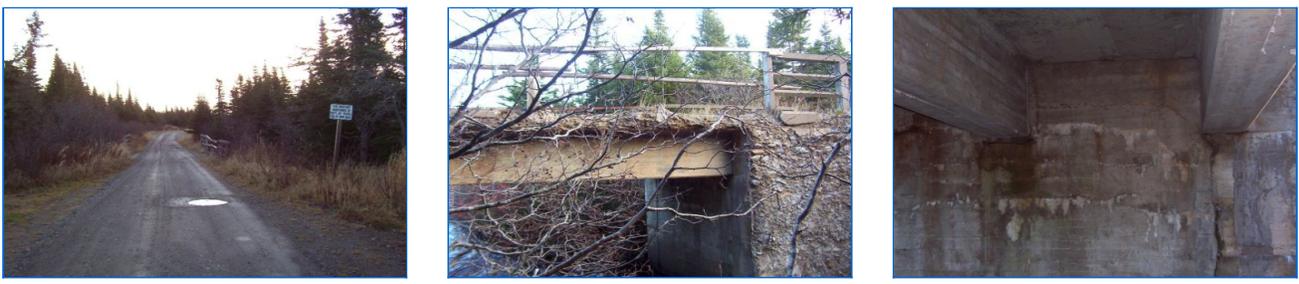
BRIDGE PHOTOS

SUBSTRUCTURE			
Condition:	P3 - Poor	Bearings:	U - Uninspectable
		Bearing Seat:	U - Uninspectable
Comments:	Previous Inspection - Concrete abutments and wingwalls. Severe deterioration of all components. new inspection - Appears to be rust staining on abutment #2 right due to the old bridge rail above. Abutment #2 right has exposed rebar		
SUPERSTRUCTURE			
Condition:	F1 - Fair	Expansion Joints:	I - Inapplicable
Comments:	Previous Inspection - 3 reinforced concrete beams. Beam one has significant longitudinal cracking with efflorescence, mostly bottom half of beam. New Inspection - Beam 3 has alligator cracking with efflorescence.		
DECK

Condition:	P3 - Poor	Curbs:	P3 - Poor
Hand Rail:	P - Poor	Roadway Condition:	I - Inapplicable
Approach Rail:	P - Poor		
Comments:	Previous Inspection - Exposed concrete deck with gravel approaches. Deck is covered with gravel, underside has some cracking with efflorescence. Deck edges and curbs are severely disintegrated. Timber hand rail installed on bridge. New Inspection - Left side deck/curb is now completely missing.		
HYDROLOGY			
Water Velocity:	1.5 m/s	Ice Problem:	N - No Problem
Water Depth:	1..5 m	Scour Problem:	N - No Problem
Waterway:	01 - Adequate	Debris Problem:	N - No Problem
Comments:	Previous Inspection - Significant debris - trees and brush - upstream of structure may move and block opening. The stream bank holding the vegetation in place does not appear solid.		
REPLACEMENT/REHABILITATION			
Next Rehab. Date:		Replacement Year:	
Antic. Rehab. Cost:	\$0	Replacement Cost:	\$0
Recommendations:	Previous Inspection - Remove structure. This bridge is on a cabin road, has 2 entrances and does not require a through road.

OBSERVATIONS			
Overall Condition:	P - Poor	Requires Further Inspection:	No
Additional Observations:	Previous Inspection - Bridge is located 800m from R210, turn off right at km 8.7, onto the old R210 alignment. Bridge can also be accessed from a road opposite from the North Harbor Intersection, 4.2km from R210. New Inspection - Appears to be small pieces of wood/lumber in girders and abutments
