GOVERNMENT OF NEWFOUNDLAND AND LABRADOR Department of Transportation and Infrastructure	<b>BRIDGE INSPECTION REPORT</b> <b>B02032020-14</b>	
<b>Date:</b> 2/3/2020	<b>Inspected By:</b> Alex Ford	<b>Category:</b> Eng. - Engineering	
<b>BRIDGE INFORMATION</b>			
<b>Site:</b>	2-198 - NORTHWEST BROOK BRIDGE (OLD)		
<b>Route:</b>	210	<b>Overall Length:</b>	8 m
<b>Year Built:</b>	1960	<b>Overall Width:</b>	5.5 m
<b>Year Last Rehab.:</b>		<b>Roadway Width:</b>	4 m
<b>Region:</b>	CENTRAL EAST	<b>Sidewalk Width:</b>	0 m
<b>Jurisdiction:</b>	Provincial	<b>Clearance to R.D. or N.W.L.:</b>	1.5 m
<b>Type of Structure:</b>	03 - Reinforced Concrete Beam/Slab	<b>Max Depth of N.W.L.:</b>	0.5 m
<b>Purpose of Structure:</b>	04 - Over Non-Navigable Waters	<b>Spans:</b>	
<b>Type of Handrail:</b>	03 - Timber Rail	<b>Span No.:</b>	<b>Length</b>
<b>Roadway Surface:</b>	01 - Concrete	1	5
<b>Alignment Vertical:</b>	01 - Good	2	0

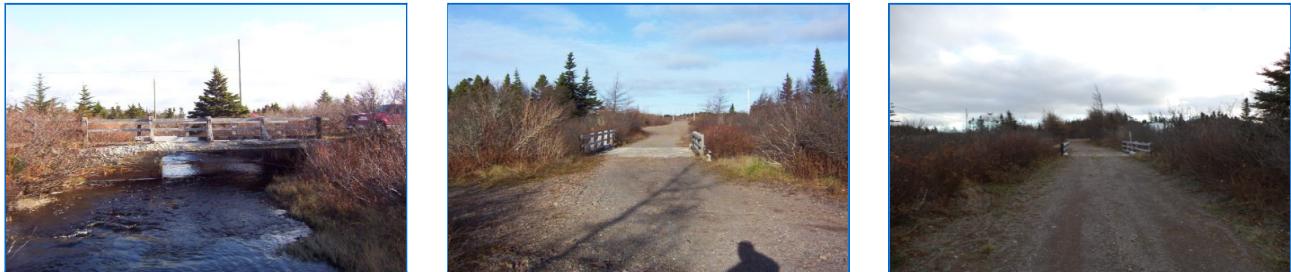
<b>SUBSTRUCTURE</b>			
<b>Condition:</b>	P1 - Poor	<b>Bearings:</b>	I - Inapplicable
		<b>Bearing Seat:</b>	I - Inapplicable
<b>Comments:</b>	Concrete abutments and wingwalls. Significant cracking, spalling, delaminations, disintegration and efflorescence throughout.

<b>SUPERSTRUCTURE</b>			
<b>Condition:</b>	P1 - Poor	<b>Expansion Joints:</b>	I - Inapplicable
<b>Comments:</b>	Reinforced concrete deck slab. Significant cracking, spalling, delaminations, disintegration and efflorescence throughout.		
<b>DECK</b>			
<b>Condition:</b>	P1 - Poor	<b>Curbs:</b>	P1 - Poor
<b>Hand Rail:</b>	P1 - Poor	<b>Roadway Condition:</b>	P1 - Poor
<b>Approach Rail:</b>	I - Inapplicable		
<b>Comments:</b>	Exposed concrete deck with gravel approaches. Severe disintegration of deck edges with exposed rebar. Timber hand rail is rotted. 150mm x 150mm creosote timber curb is rotted and split.		
<b>HYDROLOGY</b>			
<b>Water Velocity:</b>	0.5 m/s	<b>Ice Problem:</b>	N - No Problem
<b>Water Depth:</b>	0.5 m	<b>Scour Problem:</b>	N - No Problem
<b>Waterway:</b>	01 - Adequate	<b>Debris Problem:</b>	N - No Problem
<b>Comments:</b>			
<b>REPLACEMENT/REHABILITATION</b>			
<b>Next Rehab. Date:</b>		<b>Replacement Year:</b>

<b>Antic. Rehab. Cost:</b>	\$0	<b>Replacement Cost:</b>	\$0
<b>Recommendations:</b>	Remove structure.		
<b>OBSERVATIONS</b>			
<b>Overall Condition:</b>	P1 - Poor	<b>Requires Further Inspection:</b>	No
<b>Additional Observations:</b>	This structure is used as a cabin access only. It is located on a loop road.		
<b>LEGEND:</b>			
<b>Condition Definitions:</b>		<b>Problem Definitions:</b>	
1 - *Good - [discontinued code].	F2 - Fair.	C - Unsafe (Closed to Public).	N - No Problem.
2 - *Fair - [discontinued code].	F1 - Fair.	U - Uninspectable.	P - Possible Problem.
3 - *Poor - [discontinued code].	P3 - Poor.	I - Inapplicable.	K - Known Problem.
4 - *Unsafe - [discontinued code].	P1 - Poor.		NA - Not Applicable.
G - Good.	P - Poor.		
		<b>Category Definitions:</b>	
		Maint. - Maintenance.	
		Eng. - Engineering.	
		Office - Bridge Office.	
<b>PHOTO GUIDELINES:</b>			
<b>Inspection Photos:</b>			
Please provide photos using guidelines below:
