GOVERNMENT OF NEWFOUNDLAND AND LABRADOR Department of Transportation and Infrastructure	BRIDGE INSPECTION REPORT B06182024-1	
Date: 6/18/2024	Inspected By: Damien Burns	Category: Eng. - Engineering	
BRIDGE INFORMATION			
Site:	2-178 - PIPER'S HOLE BRIDGE (OLD)		
Route:	210	Overall Length:	36 m
Year Built:	1939	Est: No	Overall Width: 6 m
Year Last Rehab.:		Est: No	Roadway Width: 5.5 m
Region:	CENTRAL EAST	Sidewalk Width:	0 m
Jurisdiction:	Provincial	Clearance to R.D. or N.W.L.:	4 m
Type of Structure:	06 - Concrete Arch/TechSpan	Max Depth of N.W.L.:	0.5 m
Purpose of Structure:	04 - Over Non-Navigable Waters	Spans:	
Type of Handrail:	02 - Concrete Rail	Span No.:	Length
Roadway Surface:	01 - Concrete	1	16
Alignment Vertical:	01 - Good	2	16
Alignment Horizontal:	01 - Good	3	0
Restrictions:	Yes	4	0
Describe Restrictions:	ATV's and pedestrians only.		
5	0	6	0
BRIDGE PHOTOS

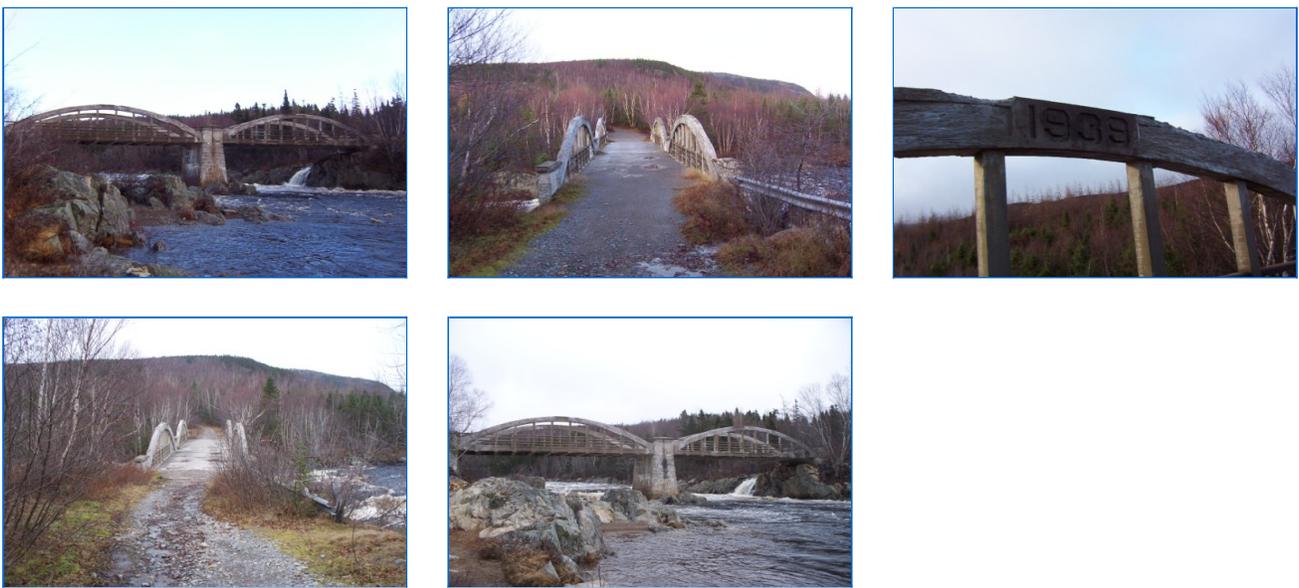
Additional Observations: - Bridge is in overall poor condition, P3 with P1 and F1 areas. There is severe concrete denigration throughout the entire structure. - North wingwalls are uninspectable. - There are areas of the fascia and deck soffit that are stained black. Suspected to be algae or mold from the water below. - Recommended to remove the structure

Next Rehab. Date:		Replacement Year:	2027
Antic. Rehab. Cost:	\$0	Replacement Cost:	\$0
Recommendations:	Recommended to remove the structure.
