GOVERNMENT OF
NEWFOUNDLAND
AND LABRADOR
Department of Transportation and Infrastructure

BRIDGE INSPECTION REPORT
B08022021-5

Date: 5/6/2021

Site:	2-178 - PIPER'S HOLE BRIDGE (OLD)				
Route:	210	Overall Length:	36 m		
Year Built:	1939	Est: No	Overall Width:	6 m	
Year Last Rehab.:		Est: No	Roadway Width:	5.5 m	
Region:	CENTRAL EAST	Sidewalk Width:	0 m		
Jurisdiction:	Provincial	Clearance to R.D. or N.W.L.:	4 m		
Type of Structure:	06 - Concrete Arch/TechSpan	Max Depth of N.W.L.:	0.5 m		
Purpose of Structure:	04 - Over Non-Navigable Waters	Spans:			
Type of Handrail:	02 - Concrete Rail	<u>Span No.:</u>	<u>Length</u>	<u>Span No.:</u>	<u>Length</u>
Roadway Surface:	01 - Concrete	1	16	4	0
Alignment Vertical:	01 - Good	2	16	5	0
Alignment Horizontal:	01 - Good	3	0	6	0
Restrictions:	Yes				
Describe Restrictions:	ATV's and pedestrians only.

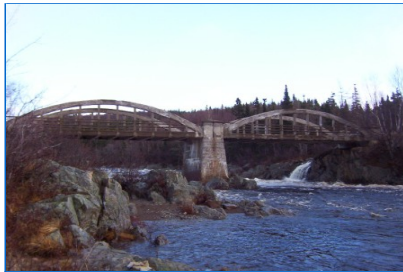
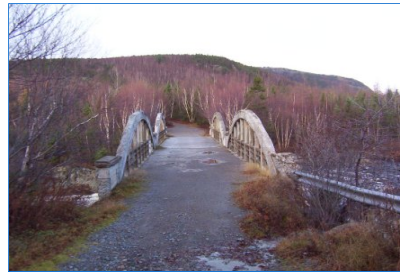
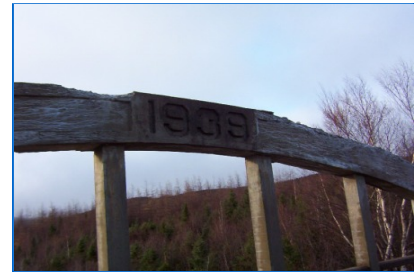
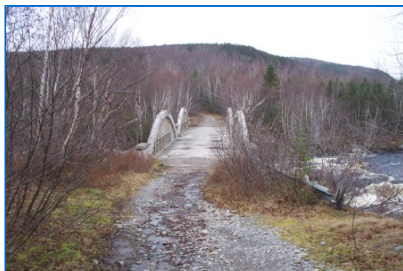
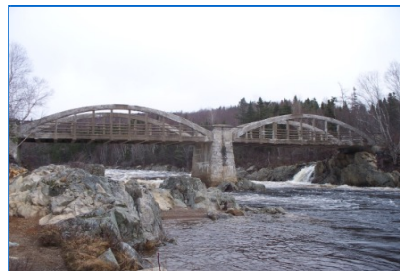
Condition:	P - Poor	Bearings:	I - Inapplicable
		Bearing Seat:	U - Uninspectable
Comments:	Concrete abutments and wingwalls. Severe deterioration throughout.

SUPERSTRUCTURE			
Condition:	P - Poor	Expansion Joints:	I - Inapplicable
Comments:	Concrete bowstring arch structure. Severe deterioration of arches, cracking with efflorescence of deck cross beams.		
DECK			
Condition:	P - Poor	Curbs:	P1 - Poor
Hand Rail:	P1 - Poor	Roadway Condition:	P1 - Poor
Approach Rail:	I - Inapplicable		
Comments:	Exposed concrete deck, top has severe weathering, bottom shows limited deterioration. Concrete rails and curbs severely deteriorated, sections missing. Approach two washed out.		
HYDROLOGY			
Water Velocity:	1.5 m/s	Ice Problem:	N - No Problem
Water Depth:	5 m	Scour Problem:	K - Known Problem
Waterway:	01 - Adequate	Debris Problem:	N - No Problem
Comments:	Significant scour/undermining of the center pier. Water overtopped structure during Hurricane Igor.		
REPLACEMENT/REHABILITATION			
Next Rehab. Date:		Replacement Year:	
Antic. Rehab. Cost:	\$0	Replacement Cost:	\$0
Recommendations:	Remove structure. If not removed: Repair hand rail. Post weight restrictions. Restrict access to only small ATV's and pedestrians. Post warning signs that structure is not maintained. Repair substructure including centre pier scour. Repair arches and rail.

OBSERVATIONS			
Overall Condition:	P - Poor	Requires Further Inspection:	No
Additional Observations:	Recommend inspection by someone familiar with this type of structure. External girders, ends of stringers and all arch components have severe concrete loss.		
LEGEND:			
Condition Definitions:		Problem Definitions:	
1 - *Good - [discontinued code].	F2 - Fair.	C - Unsafe (Closed to Public).	N - No Problem.
2 - *Fair - [discontinued code].	F1 - Fair.	U - Uninspectable.	P - Possible Problem.
3 - *Poor - [discontinued code].	P3 - Poor.	I - Inapplicable.	K - Known Problem.
4 - *Unsafe - [discontinued code].	P1 - Poor.		NA - Not Applicable.
G - Good.	P - Poor.		
		Category Definitions:	
		Maint. - Maintenance.	
		Eng. - Engineering.	
		Office - Bridge Office.	
PHOTO GUIDELINES:			
Inspection Photos:			
Please provide photos using guidelines below:			
<ul style="list-style-type: none"> ● Any item which inspector feels should be documented by photograph ● All items noted above as being P3, P1, P, or C ● Any evidence of known ice, scour, debris, waterway problems
