GOVERNMENT OF NEWFOUNDLAND AND LABRADOR Department of Transportation and Infrastructure	BRIDGE INSPECTION REPORT B08312023-5	
Date: 8/21/2023	Inspected By: Darrell Avery	Category: Eng. - Engineering	
BRIDGE INFORMATION			
Site:	2-067 - PLATE COVE WEST BRIDGE		
Route:	235	Overall Length:	33.8 m
Year Built:	2012	Est: No	Overall Width: 10.3 m
Year Last Rehab.:		Est: No	Roadway Width: 9 m
Region:	CENTRAL EAST	Sidewalk Width:	0 m
Jurisdiction:	Provincial	Clearance to R.D. or N.W.L.:	4 m
Type of Structure:	01 - AASH to Girder	Max Depth of N.W.L.:	2.5 m
Purpose of Structure:	03 - Over Navigable Waters	Spans:	
Type of Handrail:	04 - Steel Rail	Span No.:	Length
Roadway Surface:	02 - Asphalt	1	15.3
Alignment Vertical:	01 - Good	2	0
Alignment Horizontal:	01 - Good	3	0
Restrictions:	No	4	0
		5	0
		6	0
BRIDGE PHOTOS

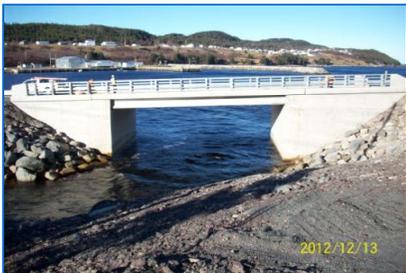
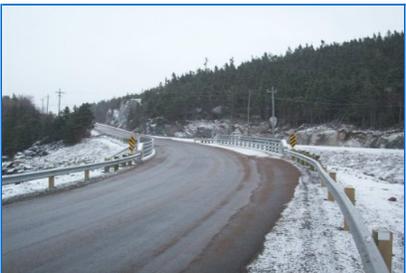
SUBSTRUCTURE			
Condition:	F2 - Fair	Bearings:	F2 - Fair
		Bearing Seat:	F2 - Fair
Comments:	Previous Inspection - Steel Sheet pile foundation/footing abutment one. Abutment 2 foundation solid rock. Steel reinforced elastomeric bearing pads, 16 total.

SUPERSTRUCTURE			
Condition:	F2 - Fair	Expansion Joints:	I - Inapplicable
Comments:	Previous inspection - 8 CPSI post tensioned girders. No expansion joints. Intergral design. spall on bottom of Girder 2 bottom.		
DECK			
Condition:	F2 - Fair	Curbs:	F2 - Fair

Hand Rail:	F2 - Fair	Roadway Condition:	F2 - Fair
Approach Rail:	F2 - Fair		
Comments:	Previous inspection - Sealant/caulking is being pulled out of saw cuts and should be replaced. ACP deteriorating around sawcut located on abutment 1. There is no structural rail on the 4 corners. New inspection - erosion at Abut. #2 left shoulder and sand windrow.		
HYDROLOGY			
Water Velocity:	0.5 m/s	Ice Problem:	N - No Problem
Water Depth:	2 m	Scour Problem:	N - No Problem
Waterway:	01 - Adequate	Debris Problem:	N - No Problem
Comments:			
REPLACEMENT/REHABILITATION			
Next Rehab. Date:		Replacement Year:	
Antic. Rehab. Cost:	\$tbd	Replacement Cost:	\$tbd
Recommendations:	Replace Sealant in saw cuts to prevent further problems. Repair shoulder at Abut. #2 left shoulder.		
OBSERVATIONS			
Overall Condition:	F2 - Fair	Requires Further Inspection:	No
Additional Observations:	previous inspection - Structure built in 2012 to replace bridge damaged by Hurricane Igor. Work was completed on this structure in 2017 to repair loss of fill from Abutment 2 left. Work included amour stone laid on Non woven Geotextile adjacent to Abutments 1 and 2 left. Rock embedded gutters were replaced as part of the Work.
