**BRIDGE INSPECTION REPORT
B08122024-3**

Date: 8/9/2024

Site:	2-087 - POINT MAY BRIDGE			Overall Length:	17.5 m
Route:	220			Overall Width:	9 m
Year Built:	1965	Est: No		Roadway Width:	7.4 m
Year Last Rehab.:	1995	Est: No		Sidewalk Width:	0 m
Region:	CENTRAL EAST			Clearance to R.D. or N.W.L.:	3.5 m
Jurisdiction:	Provincial			Max Depth of N.W.L.:	1.5 m
Type of Structure:	03 - Reinforced Concrete Beam/Slab			Spans:	
Purpose of Structure:	04 - Over Non-Navigable Waters				
Type of Handrail:	01 - Aluminum Rail			<u>Span No.:</u>	<u>Length</u>
Roadway Surface:	01 - Concrete			1	10
Alignment Vertical:	01 - Good			2	0
Alignment Horizontal:	01 - Good			3	0
Restrictions:	No

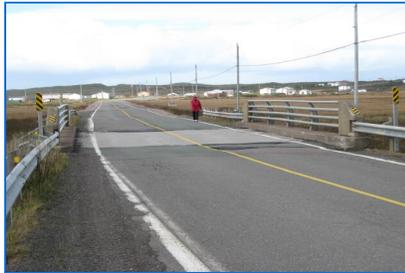
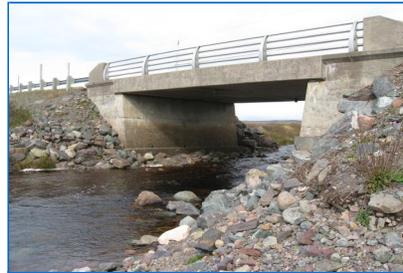
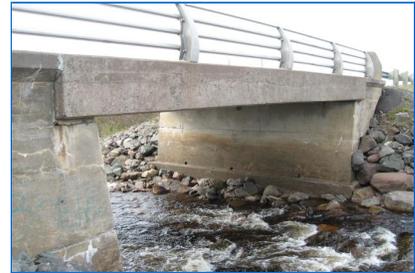
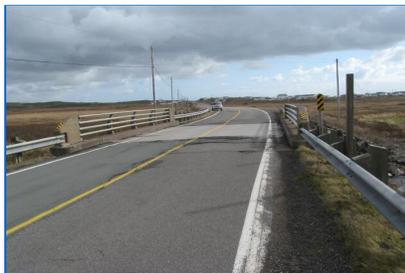
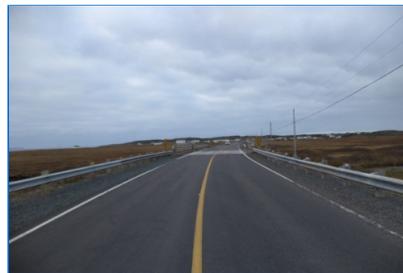
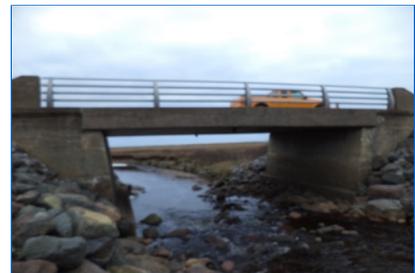
Comments: Moderate map cracking with minor amounts of efflorescence on abutments and wingwalls. No signs of scouring.

Some deterioration of Abutment 1 corner(left). Noticeable cold joint in both abutments. Bearings too high for inspection, bearing seats look to be slightly deteriorated.			
SUPERSTRUCTURE			
Condition:	F2 - Fair	Expansion Joints:	P3 - Poor
Comments:	Deck soffit in fair condition. Spalling/ cracking along both edges, worse on the downstream side with some exposed reinforcement. this likely could be due to the 45 degree drip bead on fascia. Minor spalling on soffit otherwise.		
DECK			
Condition:	F2 - Fair	Curbs:	F1 - Fair
Hand Rail:	F2 - Fair	Roadway Condition:	F1 - Fair
Approach Rail:	F1 - Fair		
Comments:	Various potholes on edges of deck near approaches, some filled with asphalt. Some hairline cracking near this as well. Curbs and end blocks have some deterioration and hairline cracking. Some minor impact to bridge rail, approach rail posts are rotten. Concrete roadway is showing sign of wear due to exposed aggregates.

HYDROLOGY			
Water Velocity:	0.5 m/s	Ice Problem:	N - No Problem
Water Depth:	0.5 m	Scour Problem:	N - No Problem
Waterway:	01 - Adequate	Debris Problem:	N - No Problem
Comments:	Stream is hitting abutment 1, rip rap protecting footing of abutment 2 from the stream.		
REPLACEMENT/REHABILITATION			
Next Rehab. Date:	2027	Replacement Year:	2045
Antic. Rehab. Cost:	\$100,000	Replacement Cost:	\$2,500,000
Recommendations:	Latex repairs on soffit edges and other necessary components. Repair structural posts. Water proof and pave structure.		
OBSERVATIONS			
Overall Condition:	F1 - Fair	Requires Further Inspection:	No
Additional Observations:
